Failure Analysis and Prevention

Edited by Aidy Ali

Fatigue Failure Analysis of a Centrifugal Pump Shaft

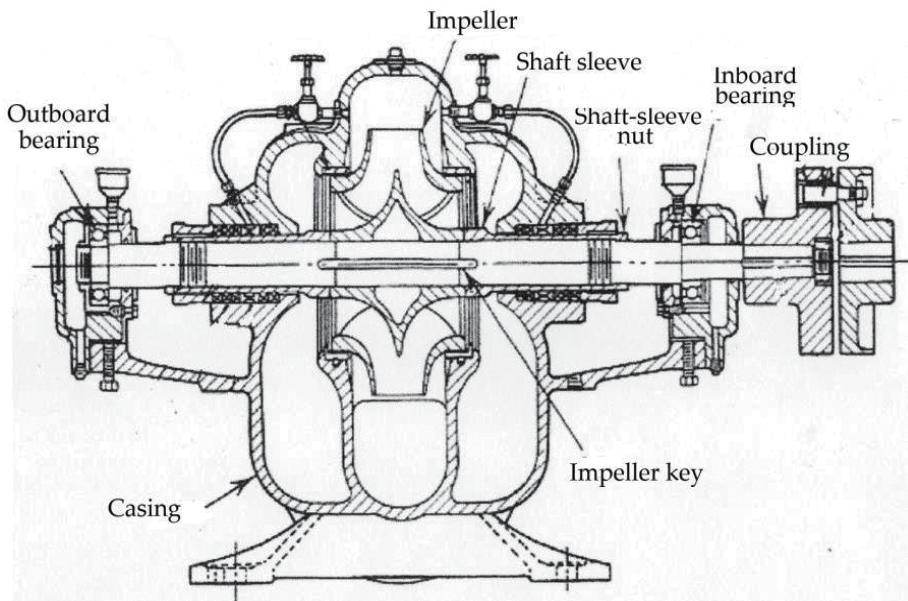
Figure 1. Cut-out section of a centrifugal pump, illustrating the main components.

The main components of a centrifugal pump are the rotor assembly and the casing. The pump rotor assembly comprises the shaft, impeller, sleeves, seals, bearings, and coupling halves, as

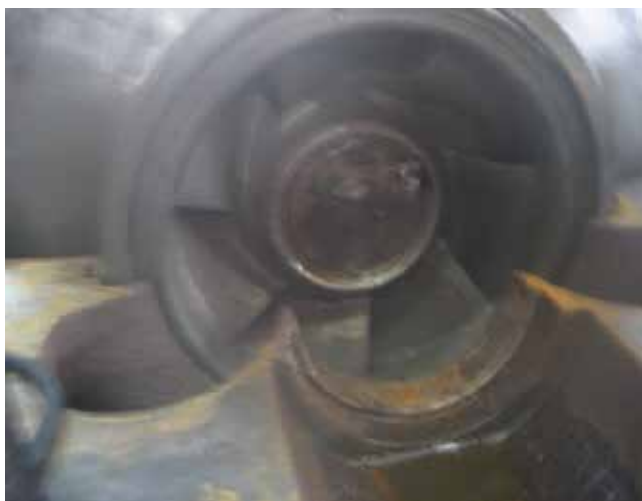
Figure 2. Failure scenario of the centrifugal pump showing the fractured rotor shaft.

The overall view of the failed centrifugal pump is shown in **Figure 2**. The driving side of the fractured rotor shaft has been removed, while the sleeve remained in place.

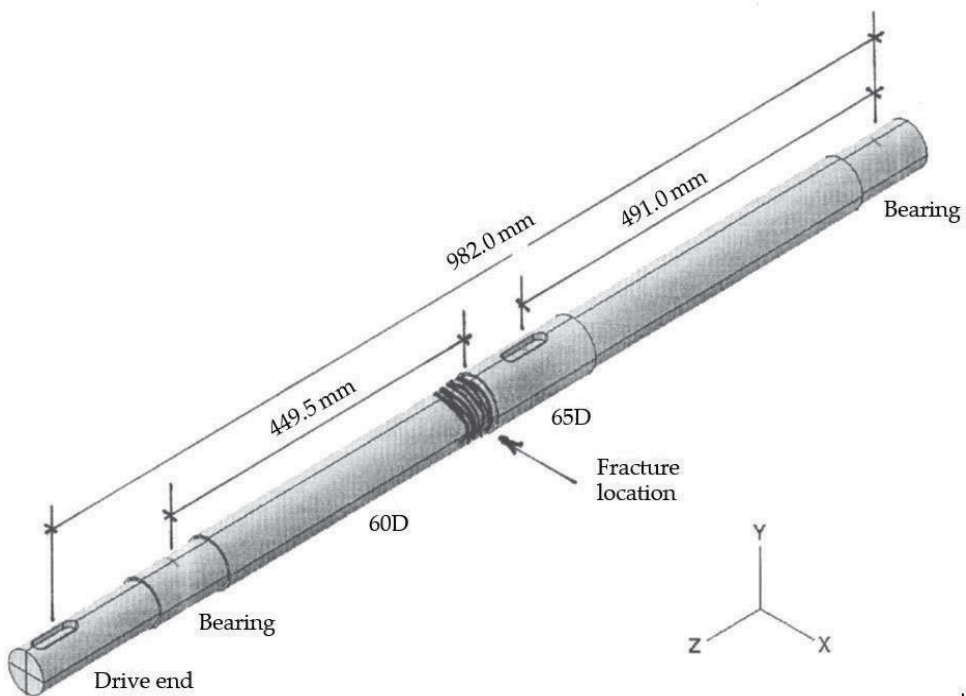
Figure 3. Simplified geometry of the rotor shaft indicating the fracture location.

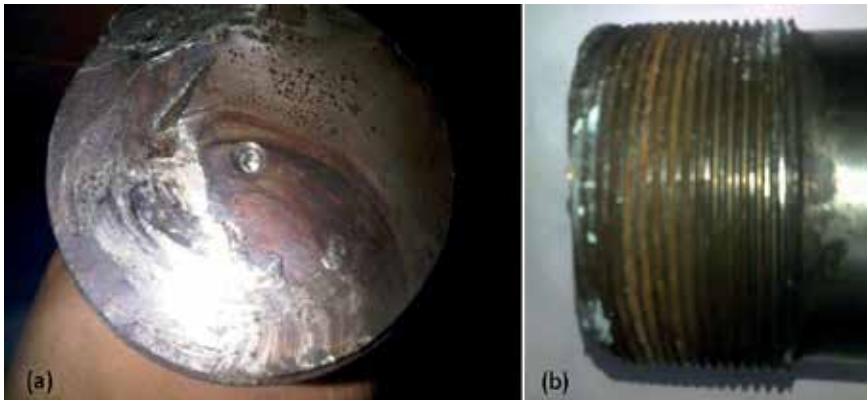
A closer visual inspection of the fractured surface reveals the morphology as shown in **Figure 4(a)**. A greater portion of the surface was flattened and smeared off due possibly to the repeated grinding against the fracture surface of the mating part while the motor runs after the complete

Figure 4. (a) Morphology of the fracture surface, indicating the fatigue *beach lines*, (b) orientation of the fracture plane perpendicular to the longitudinal axis of the shaft.

fracture. Thus, details of the fracture feature could not be extracted easily from the fractograph. However, traces of beach marks indicating fatigue failure are obvious.

It is worth noting that the fracture plane is oriented almost perpendicular to the longitudinal plane of the shaft, as shown in **Figure 4(b)**. Such orientation of the fatigue fracture plane is indicative of the Mode-I (opening) crack propagation under the induced flexural fatigue loading.

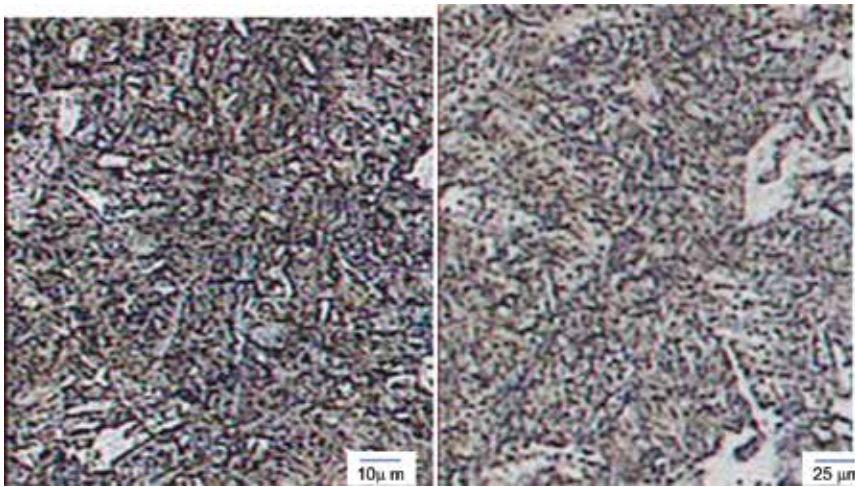
Microstructures of the steel at two different magnifications are shown in **Figure 5**. The dark and light phases represent tempered and untempered martensite, respectively, with acicular or needlelike structures.

Figure 5. Microstructures of the shaft material showing the matrix of martensite.

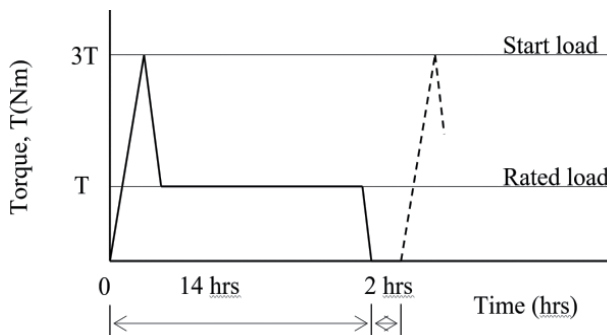
Figure 6. Torsional load sequence experienced by the failed rotor shaft.

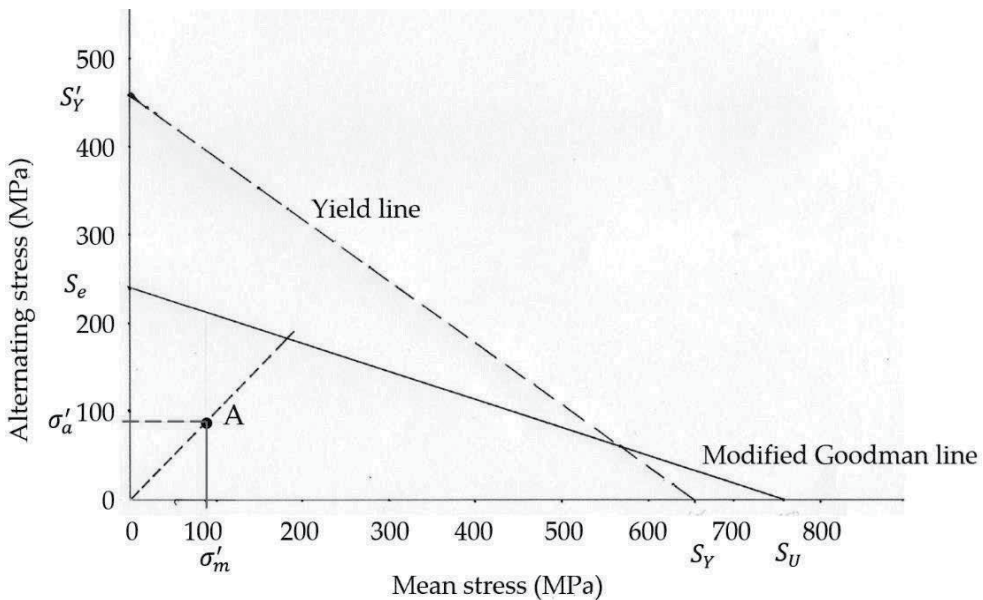
The operating localized stress condition due to the start-and-stop cycles is shown as Point A on the fatigue diagram, as illustrated in **Figure 7**.

Figure 7. Fatigue life diagram illustrating the modified Goodman failure line and the operating stress condition.

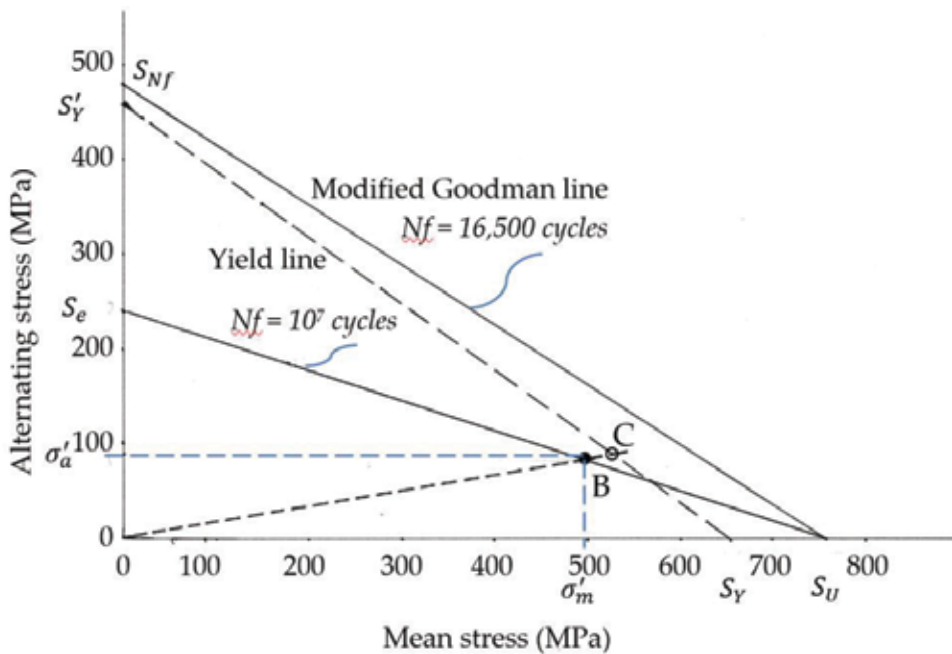
It is concluded that fatigue crack nucleated in the localized plastic zone at the threaded root region of the shaft. The relatively high mean stress component is induced by the preloading of the threaded sleeve. Under continuous fatigue loading, the crack traverses the shaft cross section leading to premature fatigue failure of the rotor shaft.

Figure 8. Fatigue life diagram illustrating the possible stress conditions with preload at $0.25S_Y$; fatigue failure (Point B) and yield (Point C).

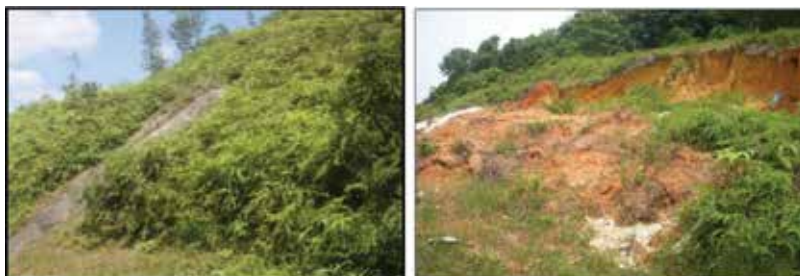
Figure 1. Condition and appearance of stable and unstable slopes soil.

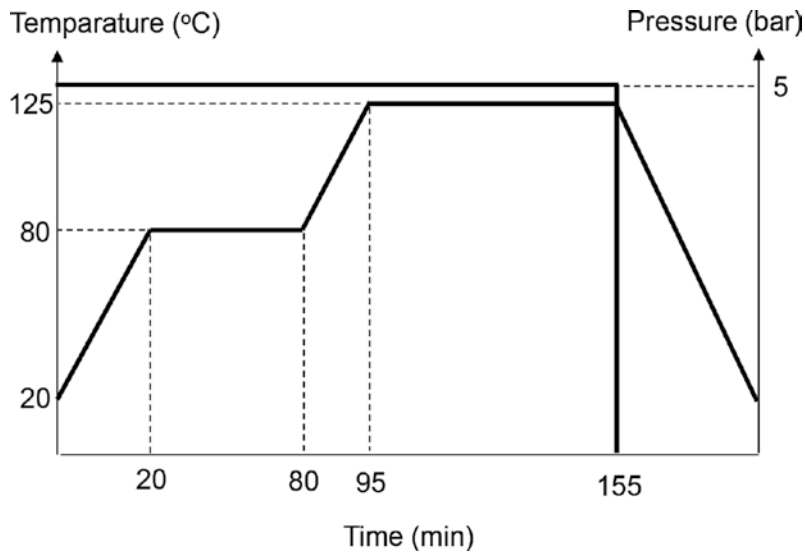
Figure 1. Curing cycle of the composite laminate fabrication.

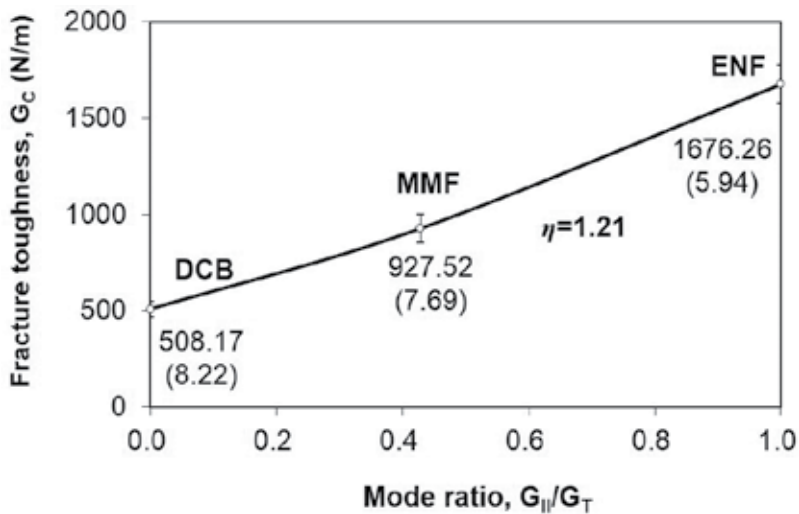
Figure 5. Variation of the fracture toughness with the mode ratio.

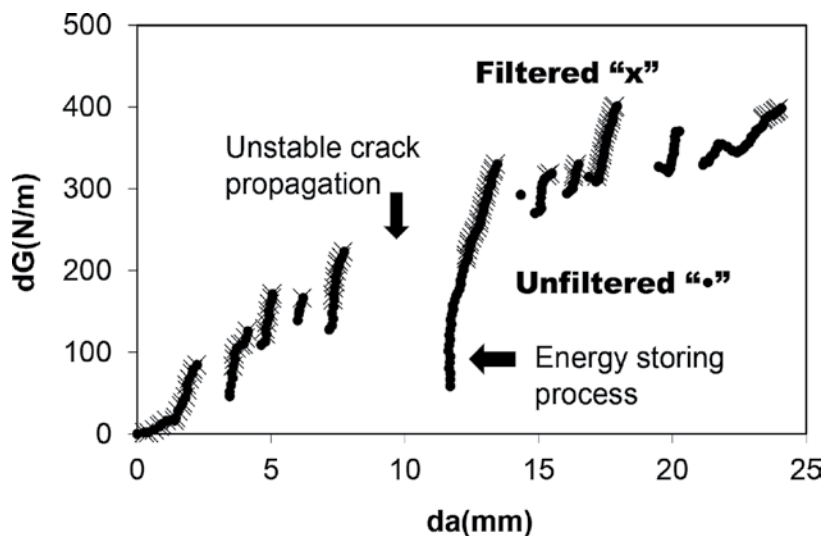
Figure 6 shows the R-curve of the DCB specimens. As shown in Figure 6, $da = a_p - a_0$ and $dG = G_p - G_C$, where a_p and G_p were calculated using Eqs. (4) and (5), respectively. The gaps between

Figure 6. R-curve of the DCB specimens.

were observed. Based on the R-curve behaviour observed, it was thus believed that fibre debonding has led to fibre bridging that enhanced the delamination growth and dissipated additional fracture energy [14].

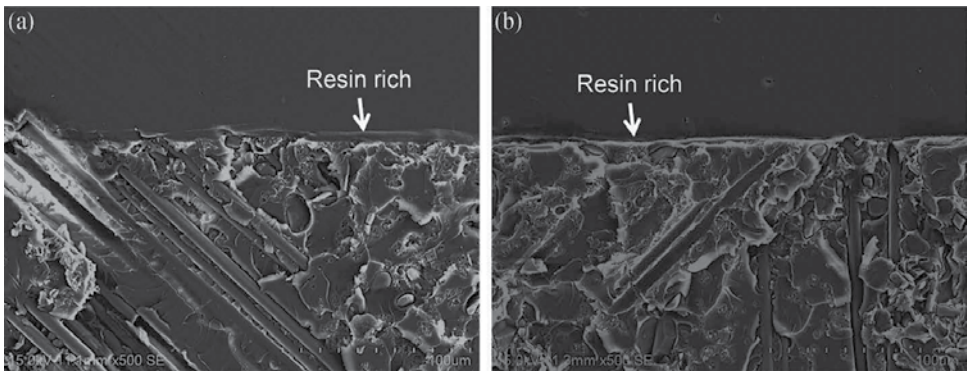
Figure 7. Crack-tip delamination of the DCB specimen: (a) 45° layer and (b) 0° layer.

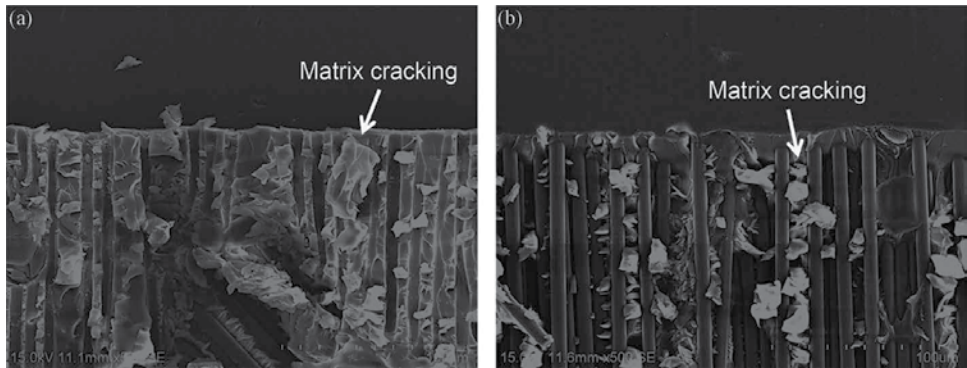
Figure 8. Crack-tip delamination of the ENF specimen: (a) 45° layer and (b) 0° layer.

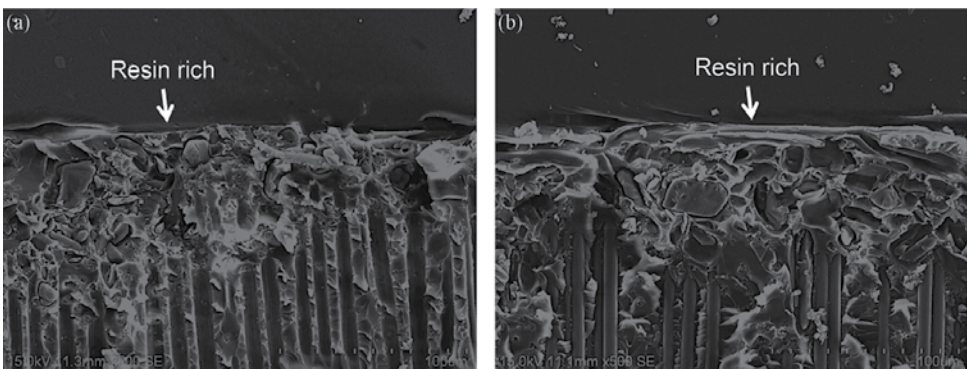
Figure 9. Crack-tip delamination of the MMF specimen: (a) 45° layer and (b) 0° layer.

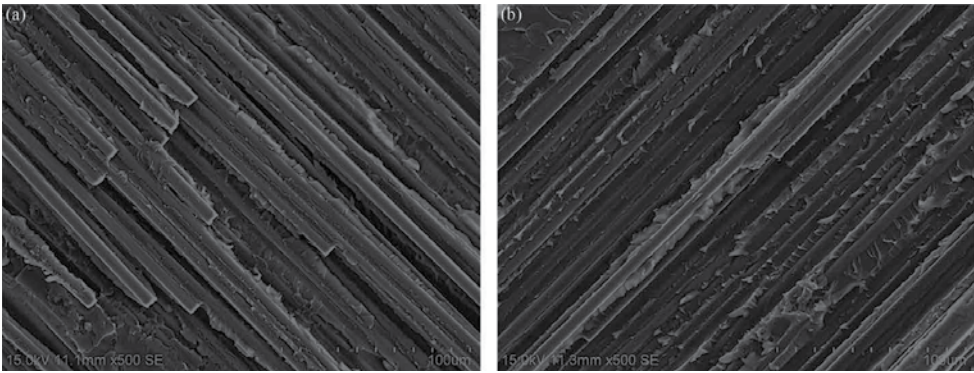
Figure 10. Delamination surfaces of the DCB specimen: (a) 45° layer and (b) 0° layer.

To further investigate the delamination behaviour in the delamination region, additional scanning electron micrographs were captured and are shown in Figures 10–12. It was observed that for the DCB specimen, the delamination was dominated by the 45° layer, where fibre debonding was the major failure mechanism. Even on the 0° surface, traces of 45° layer

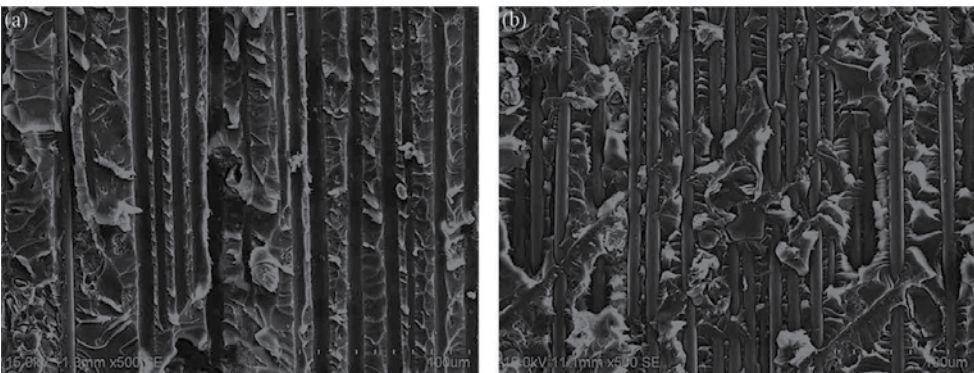
Figure 12. Delamination surfaces of the MMF specimen: (a) 45° layer and (b) 0° layer.

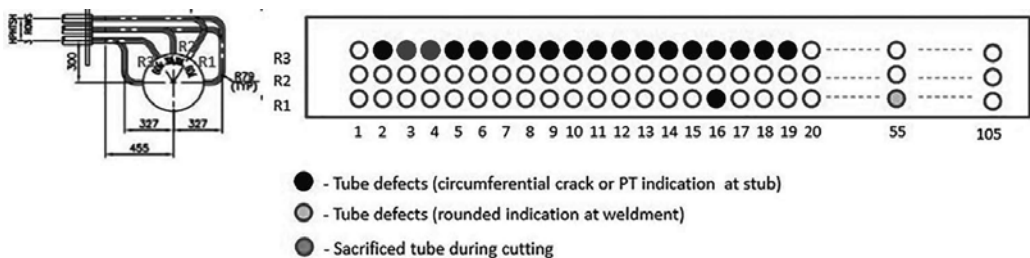
Figure 1. Tube mapping of recent failure of HPHTSH outlet header tubes.

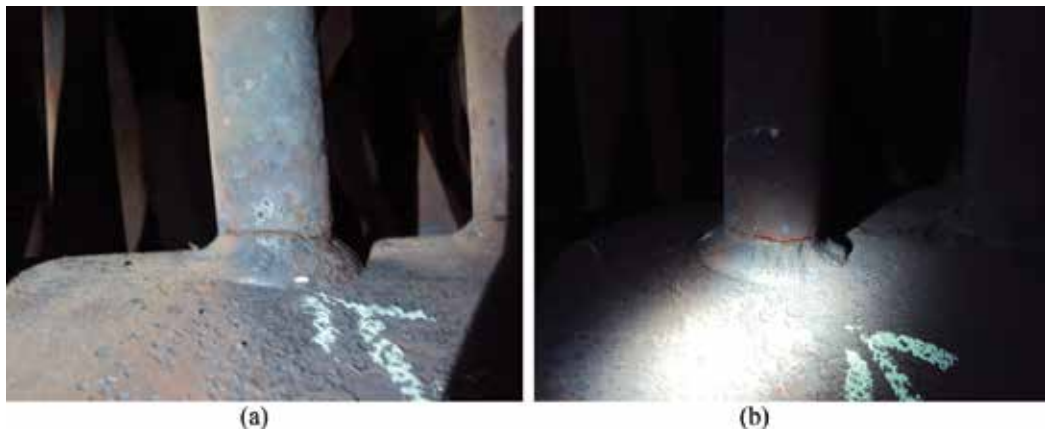
The investigation covered the failure of Tube 8, Tube 9, Tube 10 and Tube 18 of the HPHTSH section. **Figure 2** shows the samples of tube failures. Several analysis methods were carried out to ascertain the potential cause(s) of failure such as visual examination, dimensional

Figure 2. Appearance of Row 3 tube failures, (a) Tube 8 and (b) Tube 9.

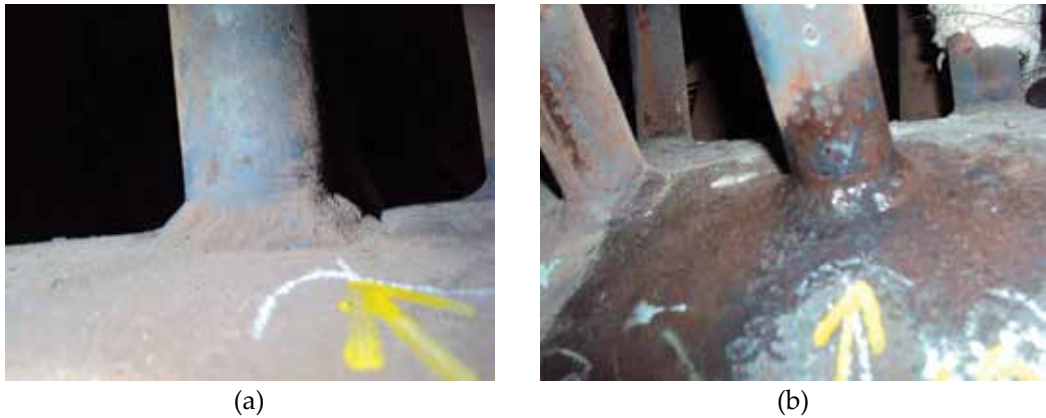
Figure 4. Appearance of tube failure at Row 3: (a) Tube 8 and (b) Tube 18.

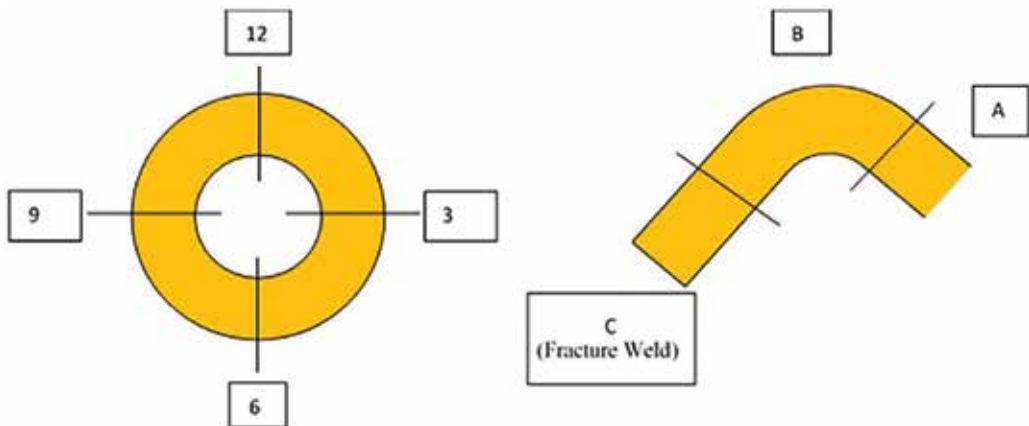
Figure 5. Dimensional references of thickness measurement on a tube.

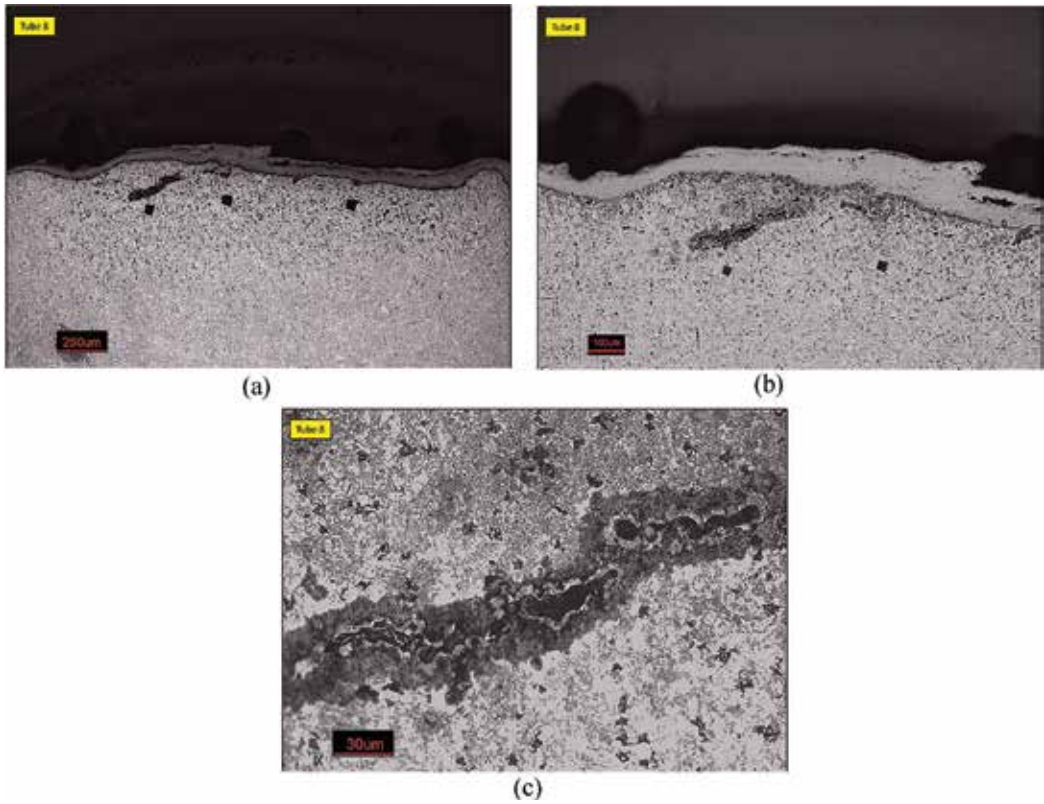
Figure 8. The microstructure of Tube 8 shows a crack at different magnification: (a) 250 μm, (b) 100 μm and (c) 30 μm.

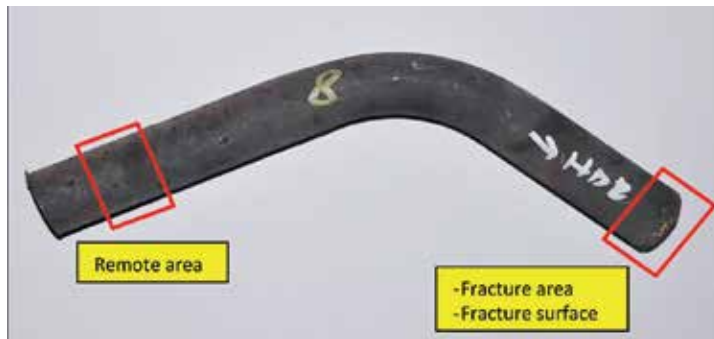
Figure 9. Dimensional reference of oxide thickness measurement.

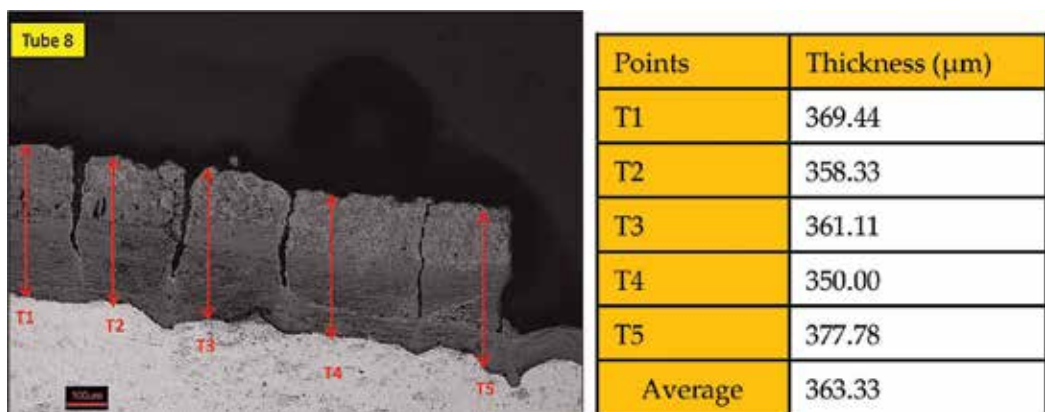
Figure 10. Internal oxide thickness at Tube 8 (fracture area).

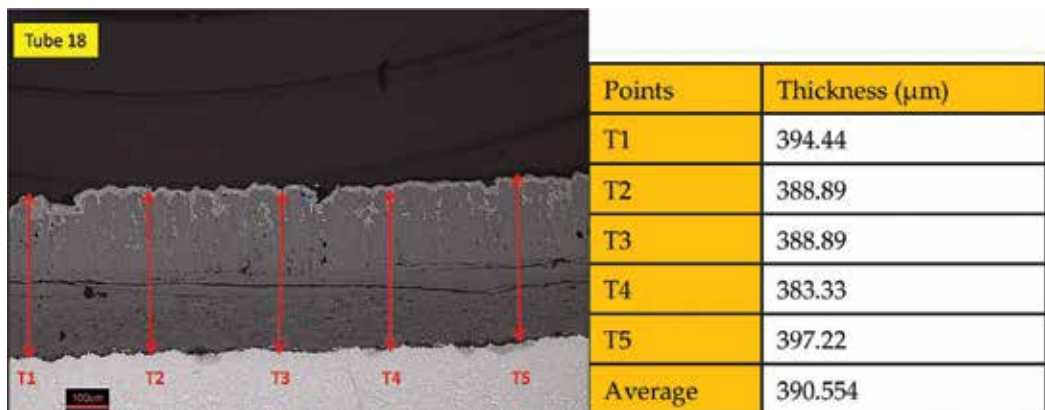
Figure 11. Internal oxide thickness at Tube 18 (remote area).

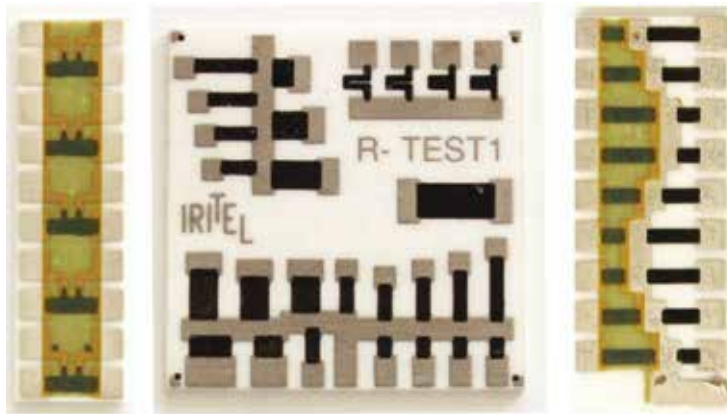
Figure 3. Thick-film test resistors of different lengths and widths used in experimental investigations.

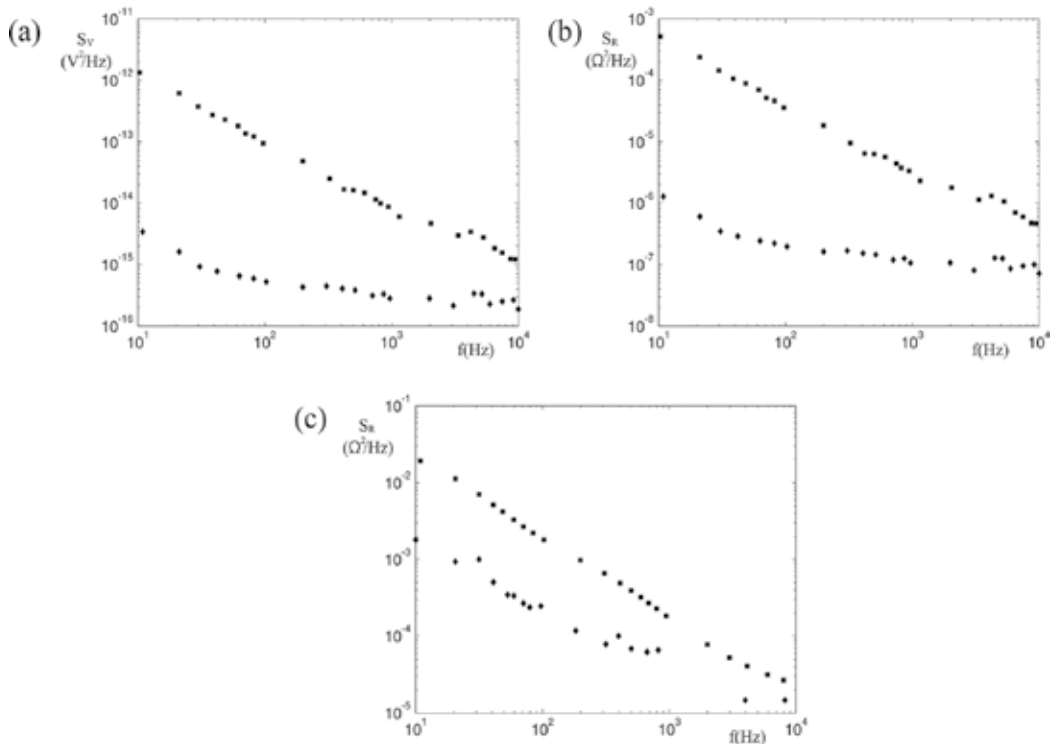
Figure 4. Experimental results for voltage and resistance noise spectra (◆—before pulse stressing, ■—after pulse stressing), for thick-film resistors with following nominal resistances: $R = 16 \text{ k}\Omega$ (a, b) and $R = 220 \text{ k}\Omega$ (c) [12].

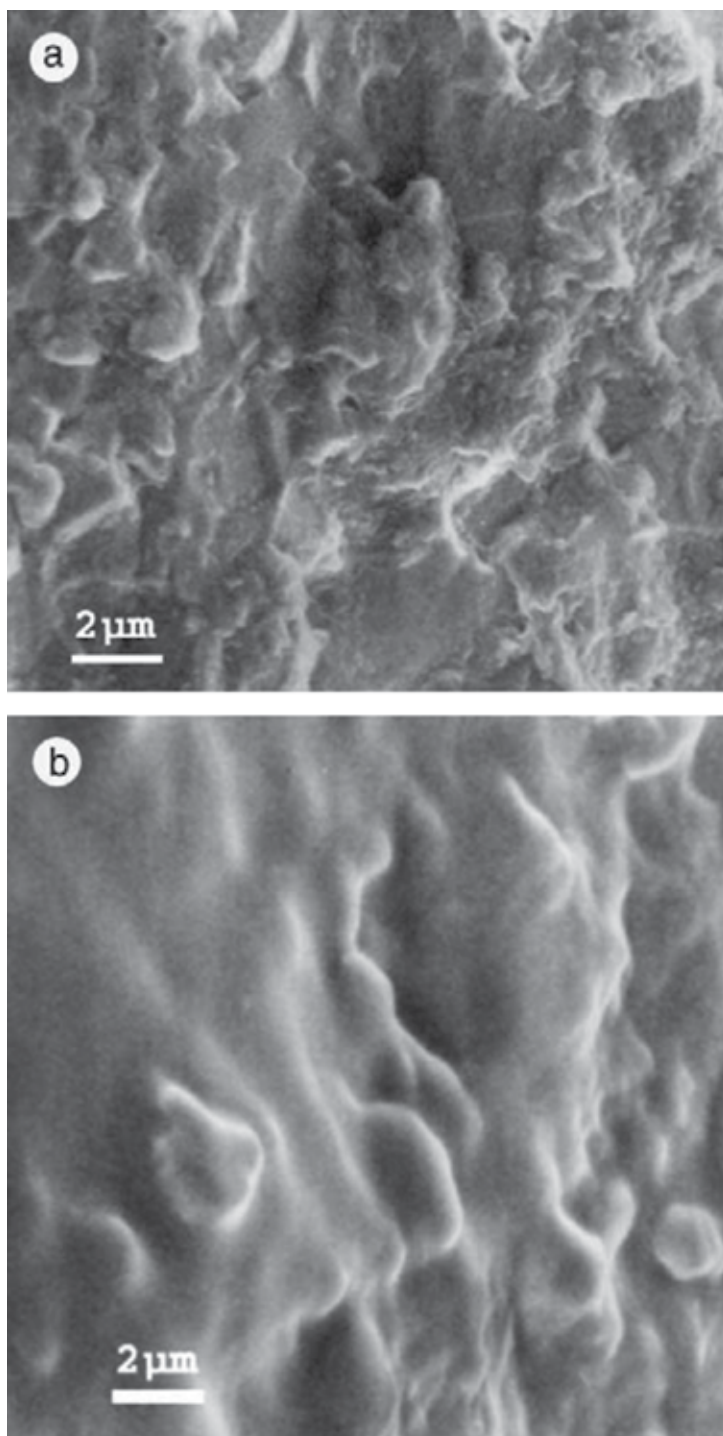
Figure 5. SEM micrographs of 10 kΩ/sq (a) and 100 kΩ/sq (b) thick-film resistors fired for 10 min at 850°C [12].

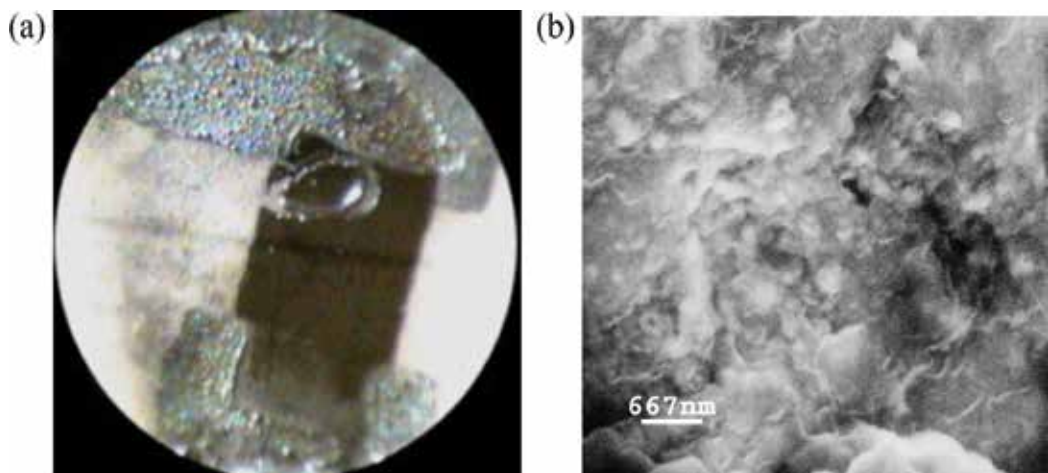
Figure 6. Photograph of 100 k Ω /sq thick-film resistor that catastrophically failed (a) and micrograph of the damaged area (b) [12].

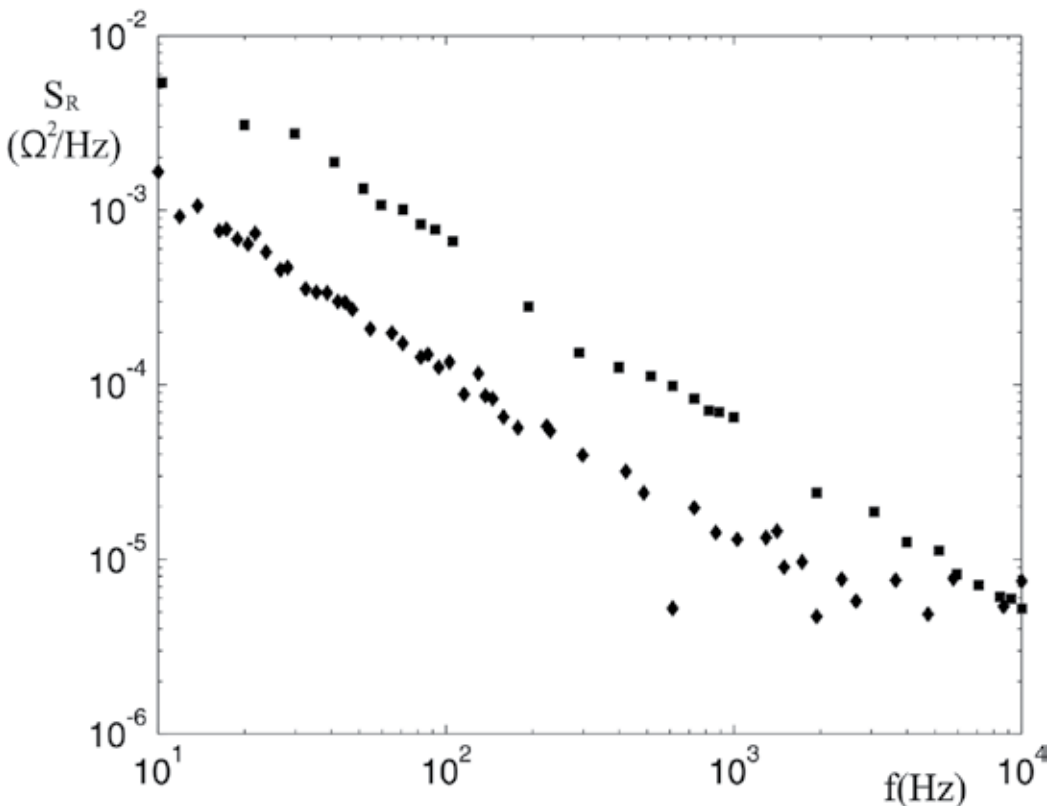
Figure 7. Experimental results for resistance noise spectrum (◆—before pulse stressing, ■—after pulse stressing) for catastrophically failed thick-film resistor with the initial resistance $R = 111.92 \text{ k}\Omega$ [12].

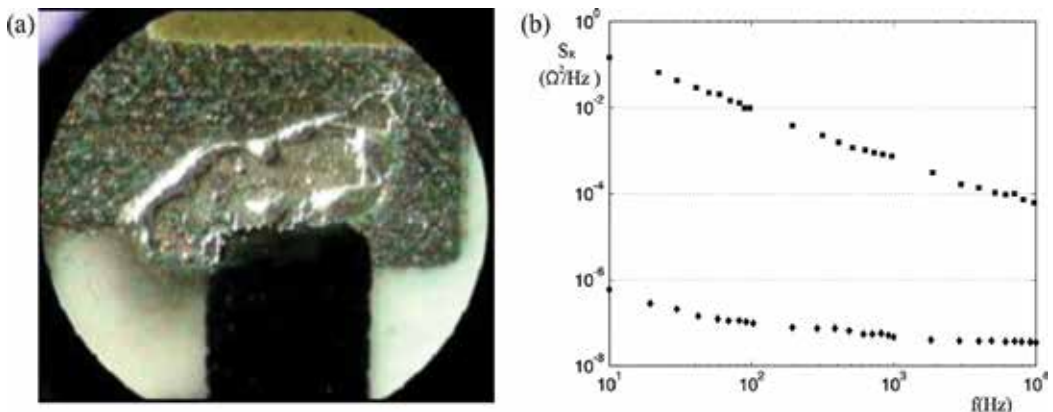
Figure 8. Photograph of catastrophically failed thick-film resistor (a) with the initial resistance $R = 7.842 \text{ k}\Omega$ and experimental results for resistance noise spectrum (\blacklozenge —before pulse stressing, \blacksquare —after pulse stressing) (b) [12].

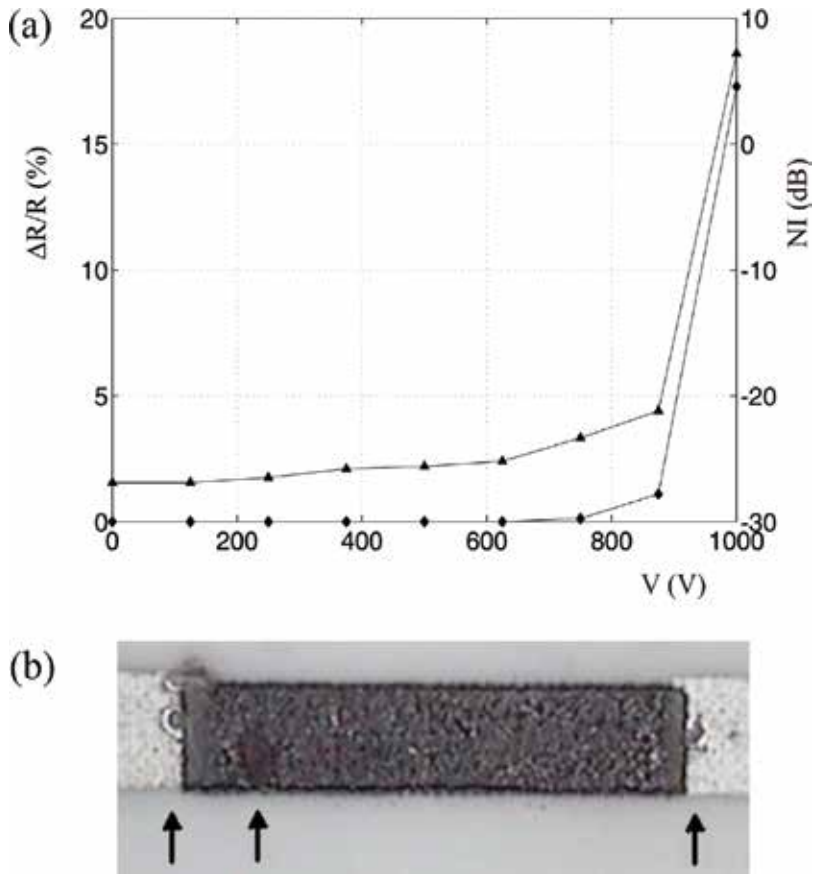
Figure 9. Experimental results for relative resistance changes and noise index during high-voltage pulse stressing of 1 k Ω /sq thick-film resistor (a) and a photograph of catastrophically failed resistor with designated failure points (b) [14].

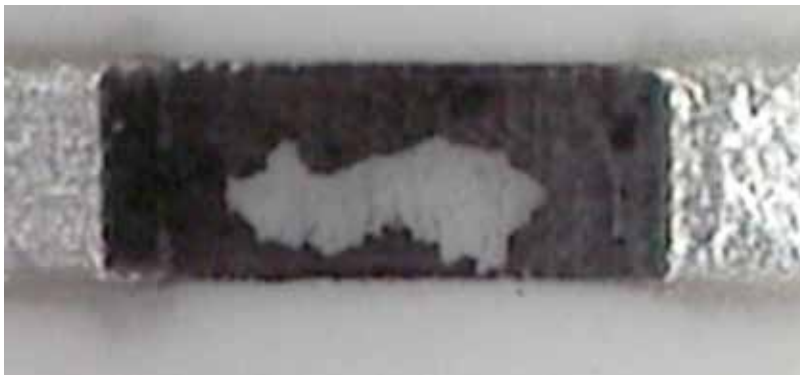
Figure 10. Photograph of catastrophically failed thick-film resistor due to the presence of hot spots caused by conducting material dispersion.

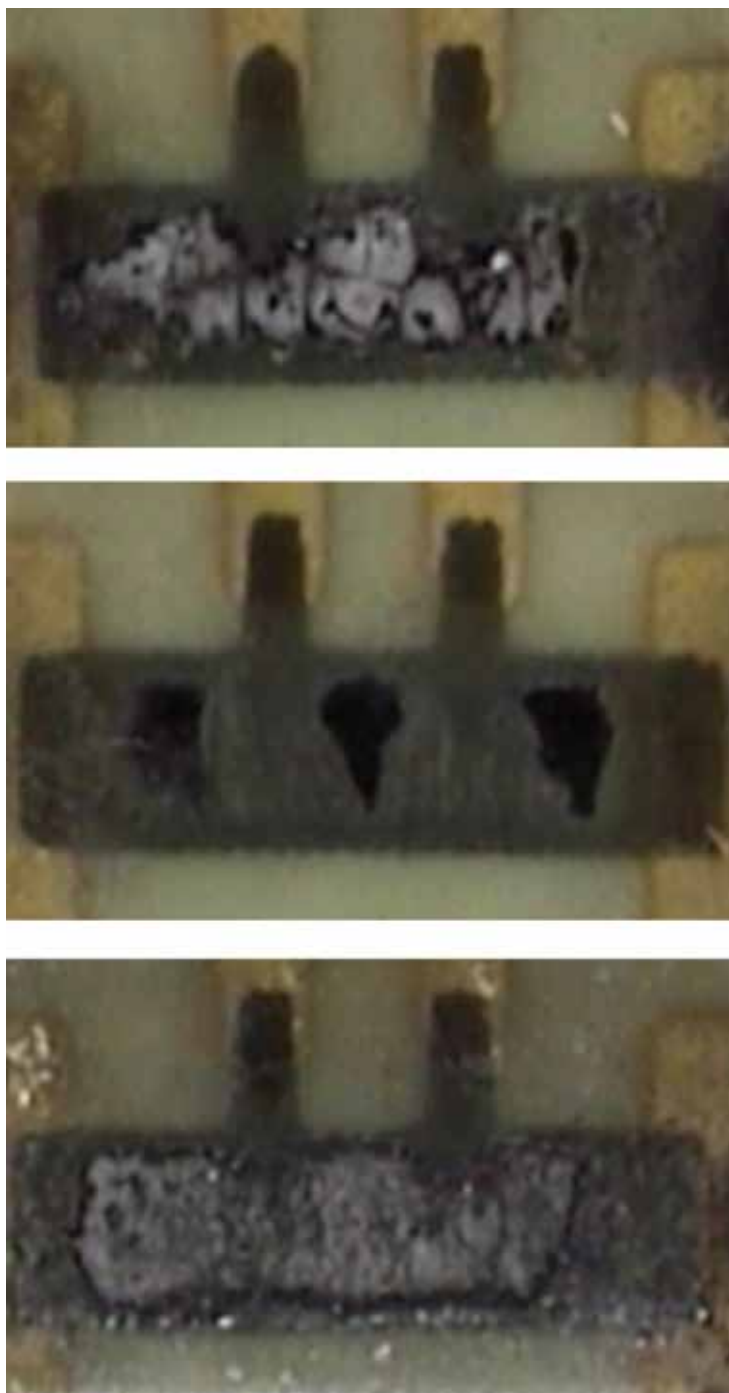
Figure 11. Photographs of progressive resistor degradation due to high-voltage pulse stressing; melting of glass encapsulant, direct exposure of resistive layer to surrounding atmosphere and burned and partially evaporated resistive layer [13].

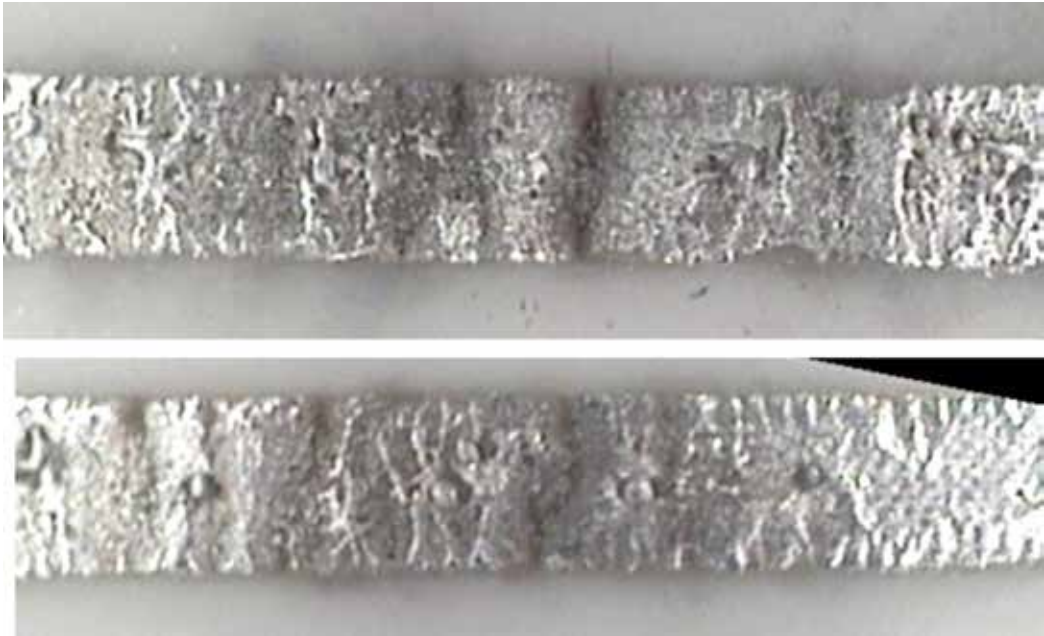
Figure 12. Photographs of failed conducting paths.

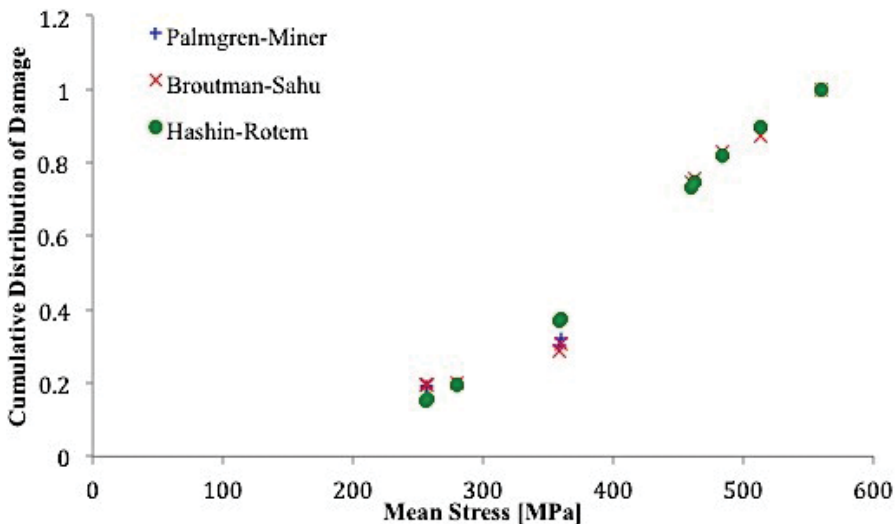
Figure 3. Cumulative distribution of damage vs. mean stress in E-glass fiber/epoxy laminate.

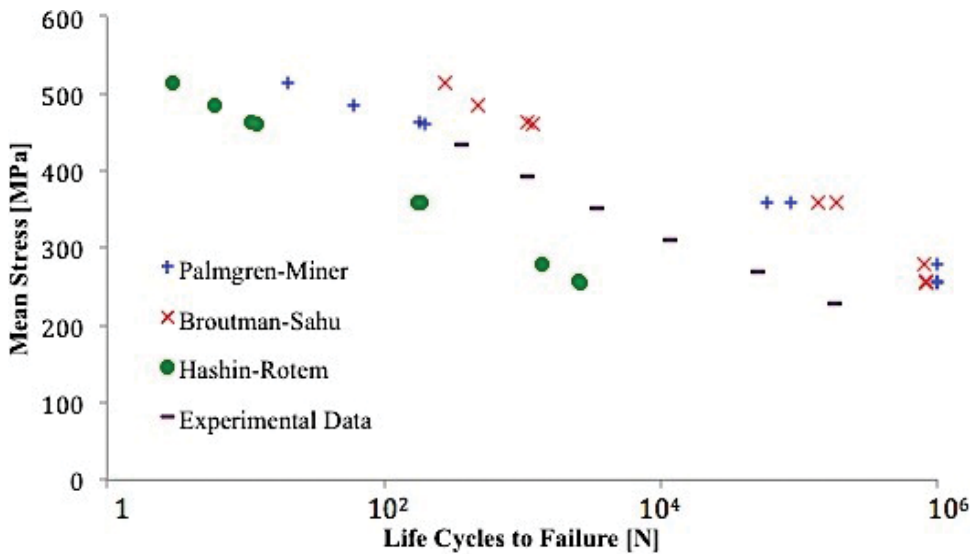
Figure 4. Mean stress vs. life to failure in E glass fiber/epoxy.

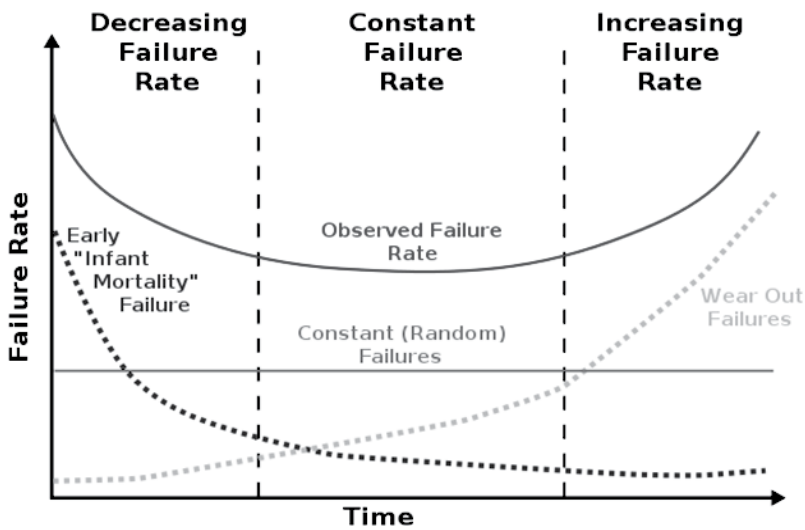
Figure 1. Bath tub curve for an ideal machine or component.

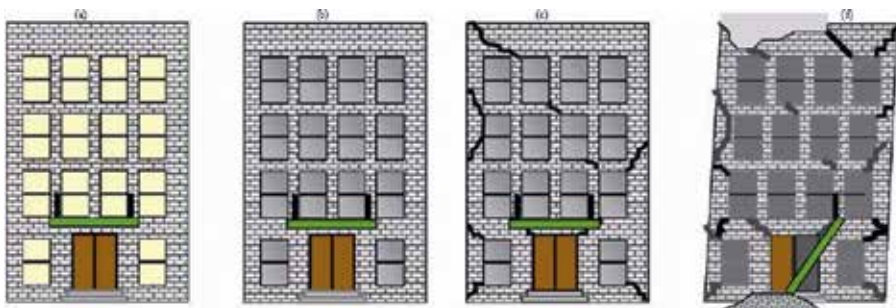
Figure 2. Levels of building performance: (a) operational, (b) immediate occupancy, (c) life-safety, and (d) collapse prevention [30].

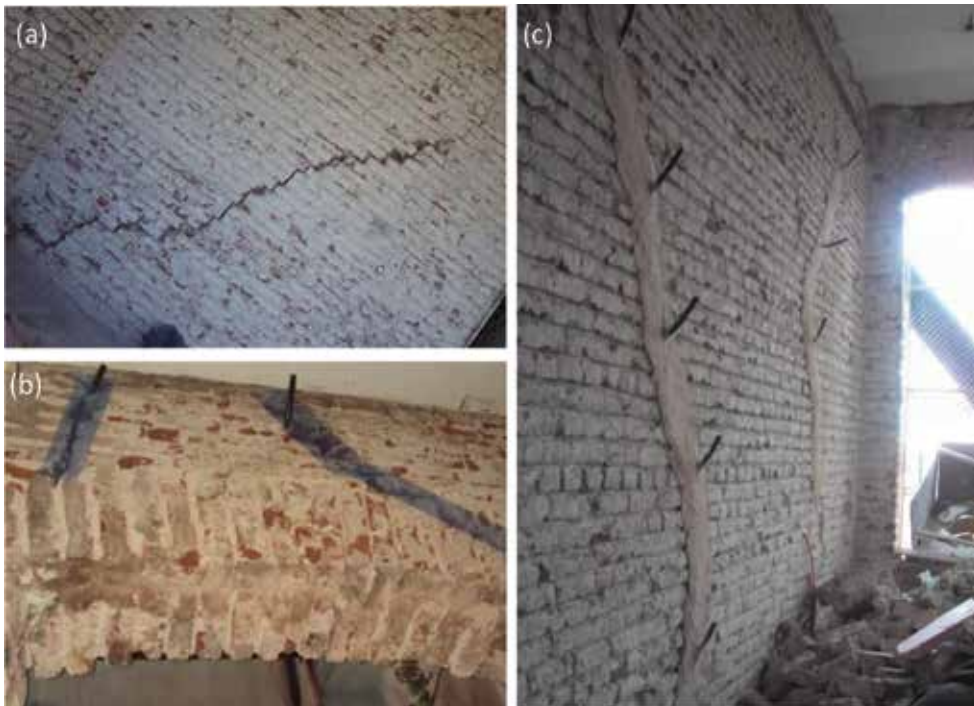
Figure 3. Injection application in the walls after plaster removal: (a) structural cracks, (b) preparation of wall surface for injection, and (c) injection application by manual technique.

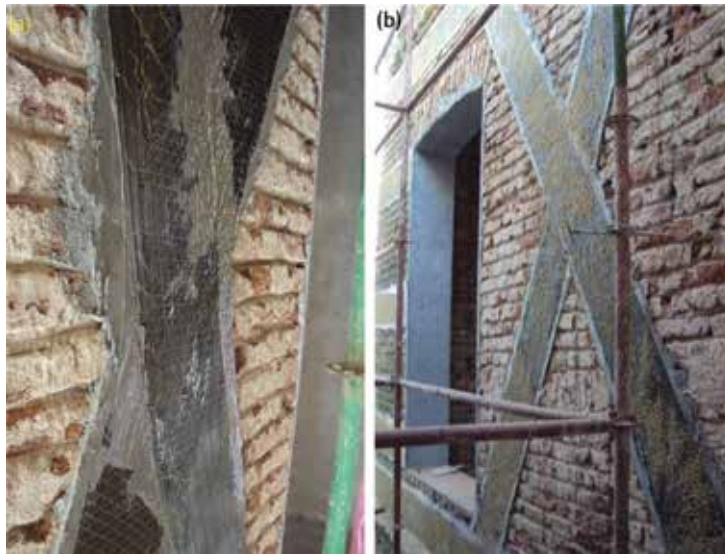
Figure 4. Carbon fiber wrap applications on masonry walls (a and b).

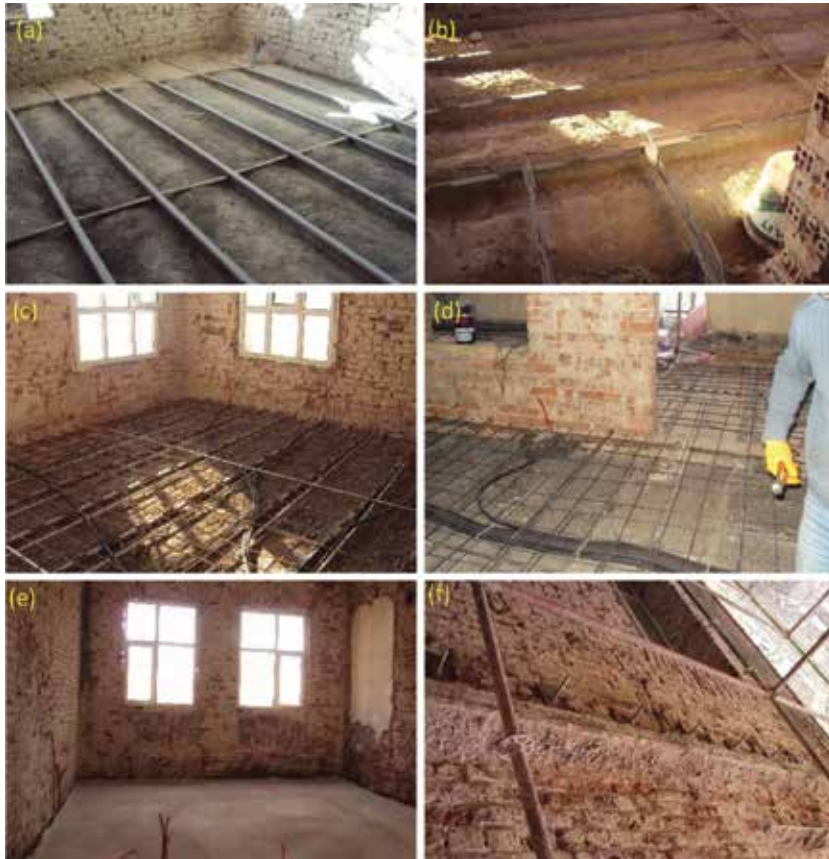
Figure 6. Retrofitting of jack arched slabs: (a) removing top layers of the slab, (b) welding of shear rebar over I-profile beam, (c) steel tie, (d) connections of stainless steel ties between the masonry walls, (e) anchorage of stainless steel, and (f) topping concrete application on slab.

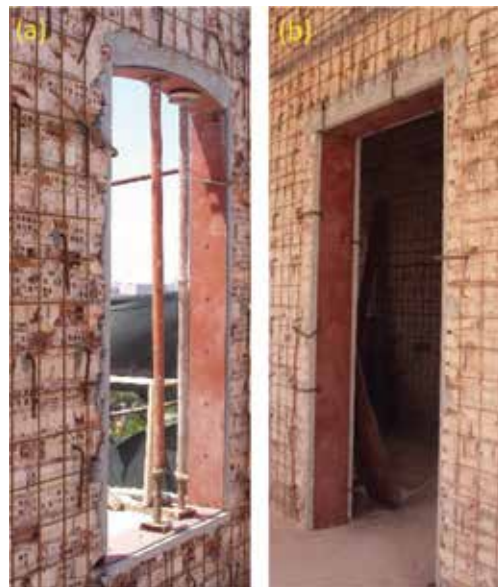
Figure 7. Retrofitting of door and window gaps using steel plates (a and b).
