Failure Analysis and Prevention

Edited by Aidy Ali

Fatigue Failure Analysis of a Centrifugal Pump Shaft

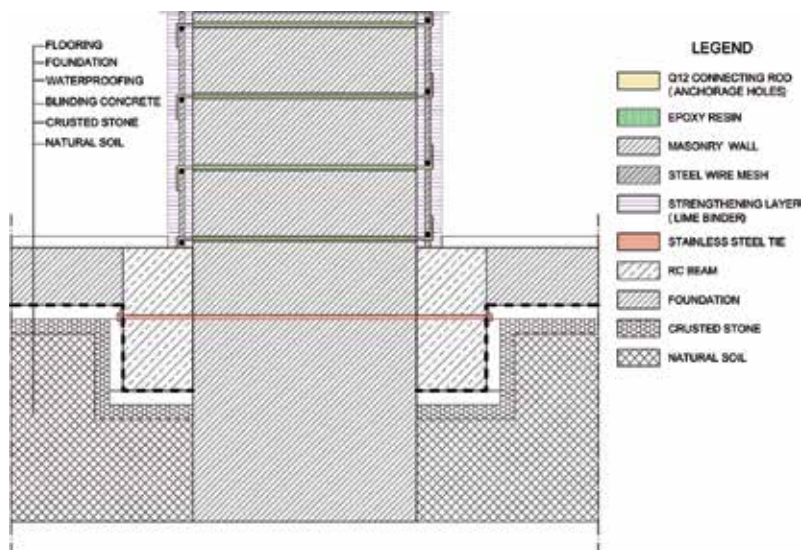
Figure 8. Retrofitting of foundations in masonry structures.

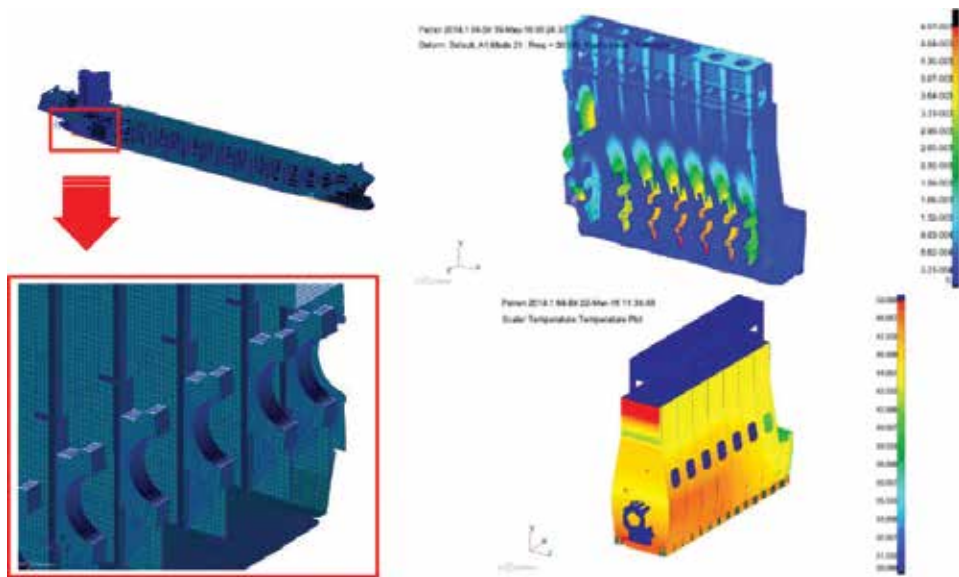
Figure 1. Engine body-ship hull interaction and thermal loads presenting a threat to structural integrity.

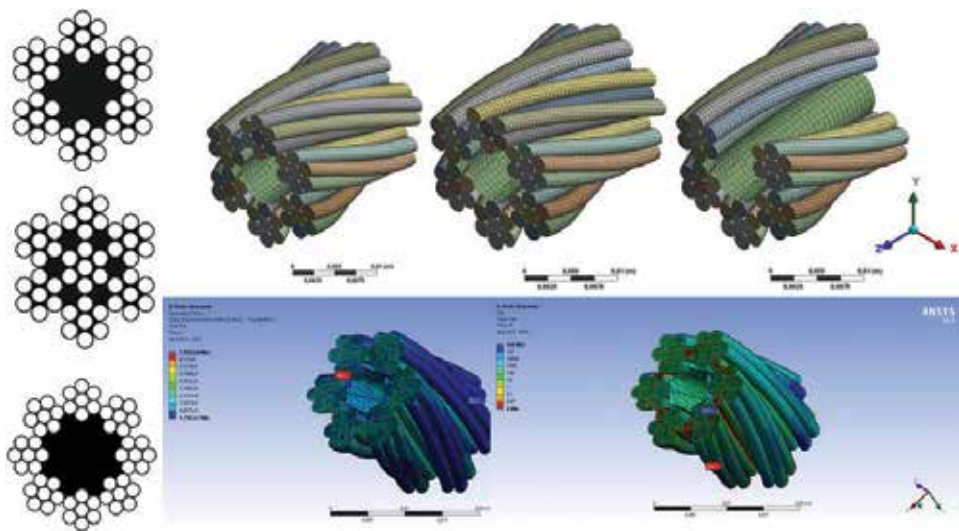
Figure 2. Numerical analysis of remaining fatigue life of a wire rope.

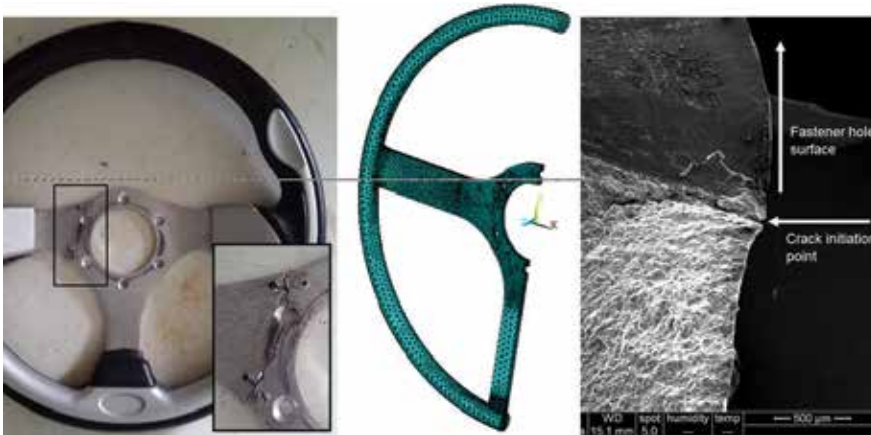
Figure 3. Experimental analysis of fractured speed boat steering wheel coupled with numerical analysis.

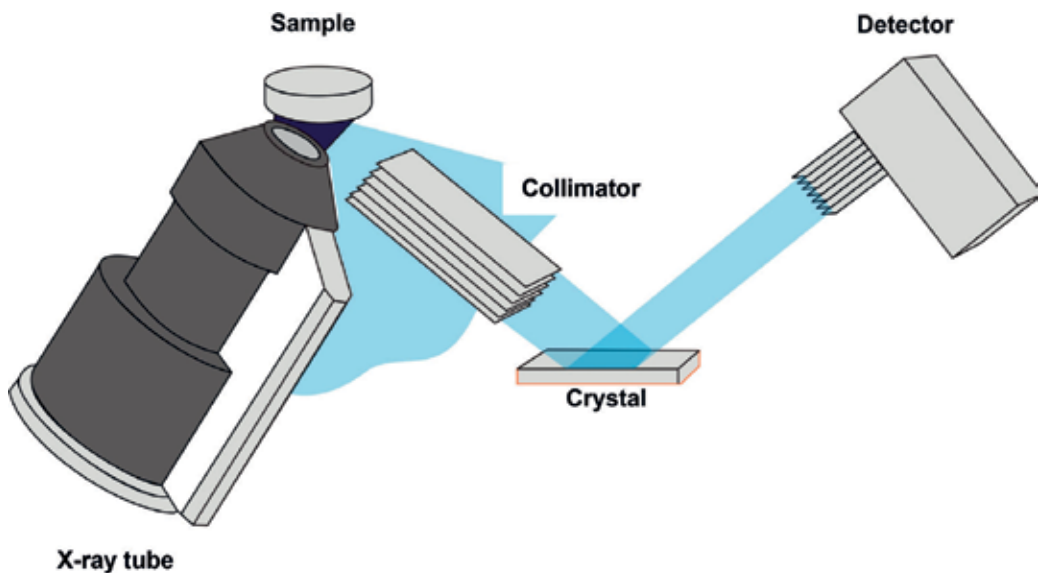
Figure 1. X-ray fluorescence spectrometer set-up (Source: PANalytical, the Analytical X-ray Company [8]).

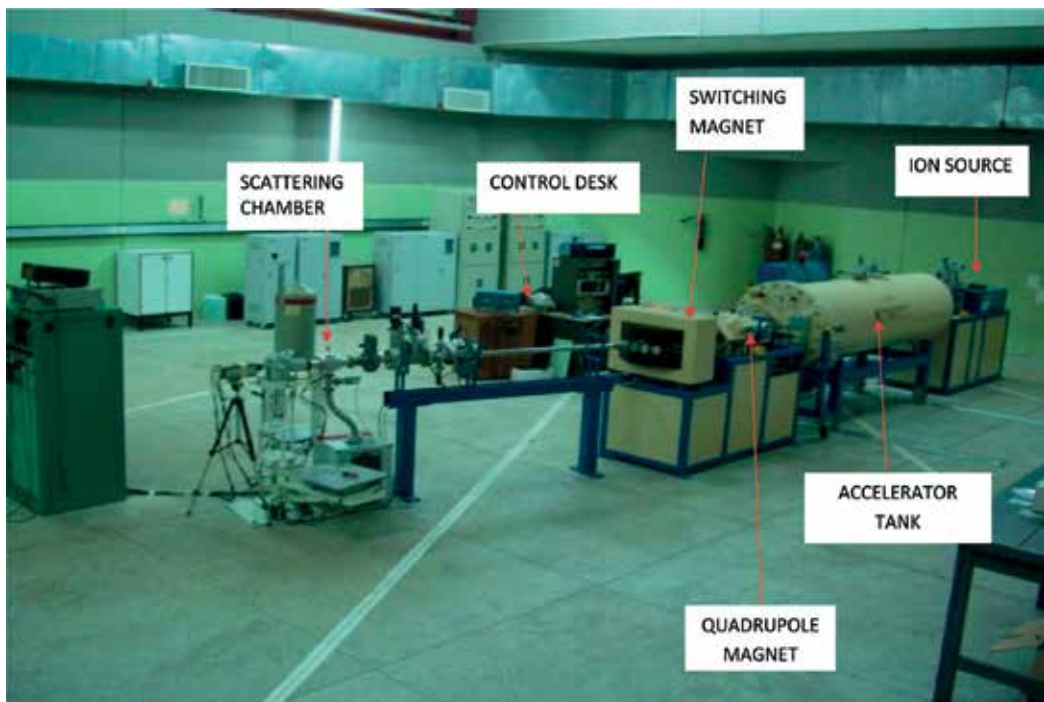
Figure 2. General view of ion beam analysis (IBA) setup at the Centre for Energy Research and Development (CERD), Obafemi Awolowo University, Ile-Ife, Nigeria (Source: [11, 13]).

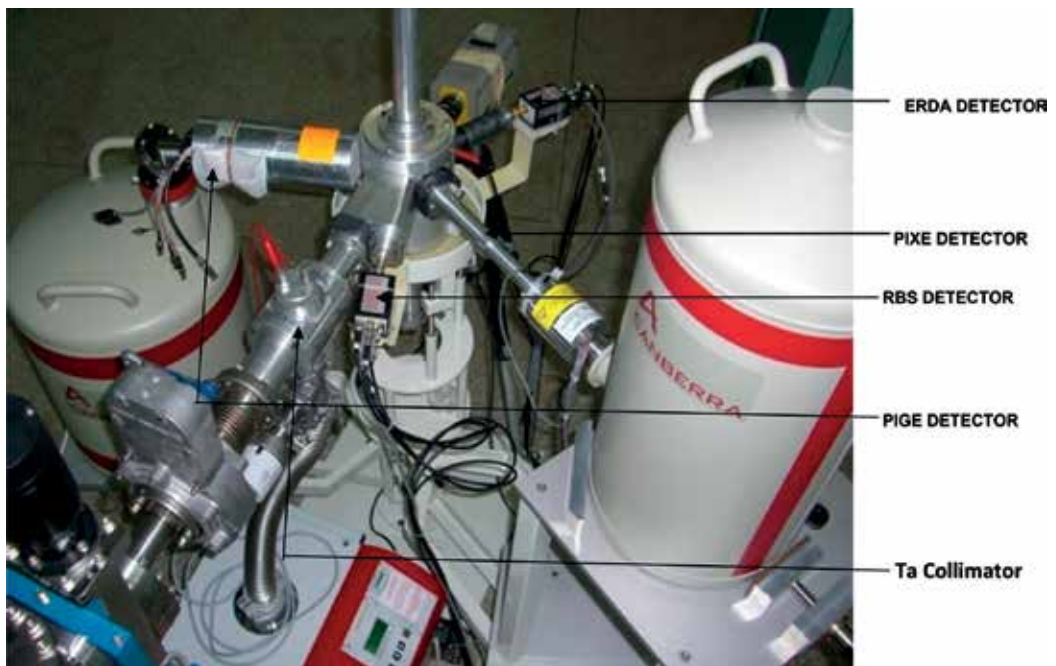
Figure 3. General view of the IBA End Station at CERD, OAU, Ife, Nigeria showing four ports and a window for RBS, PIXE, ERDA, and PIGE detectors (Source: [13]).

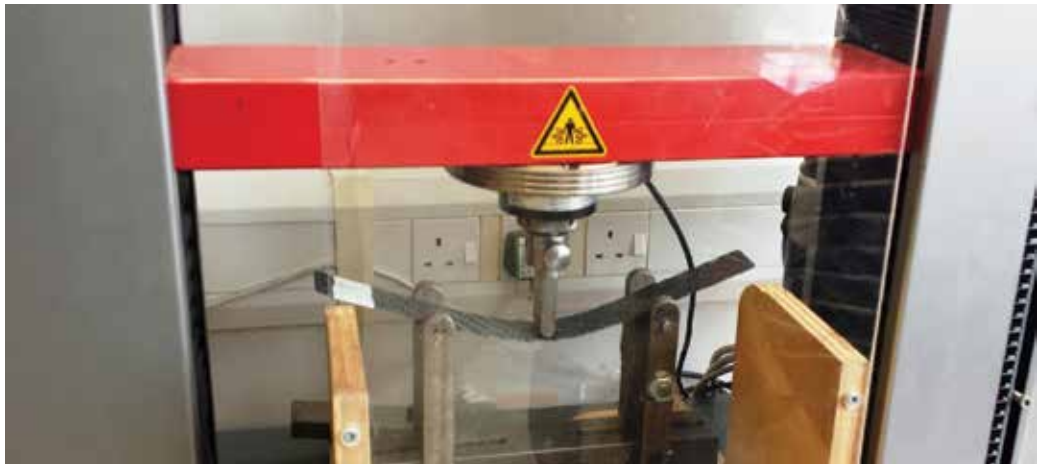
Figure 1. Flexural test equipment: universal testing machine.

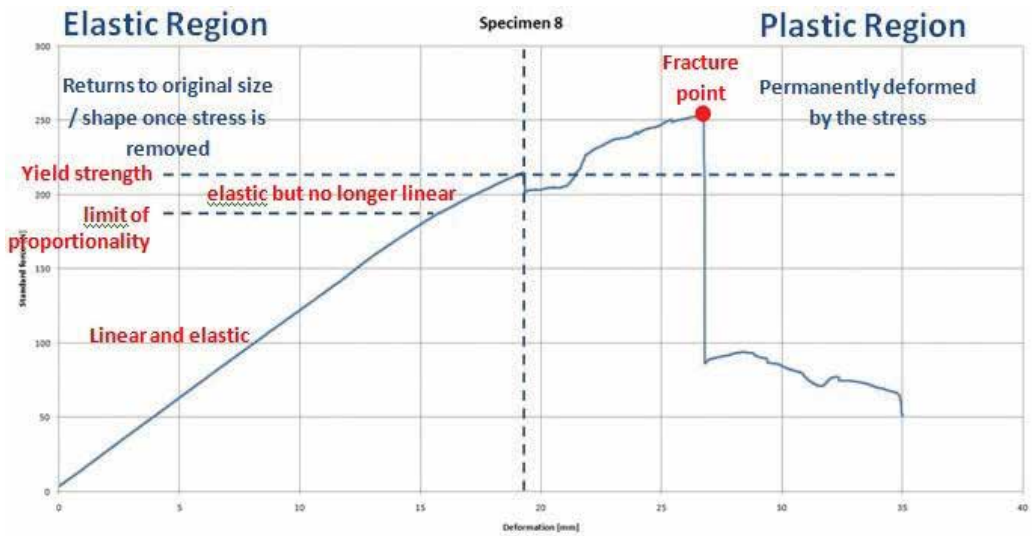
Figure 2. Control sample specimen.

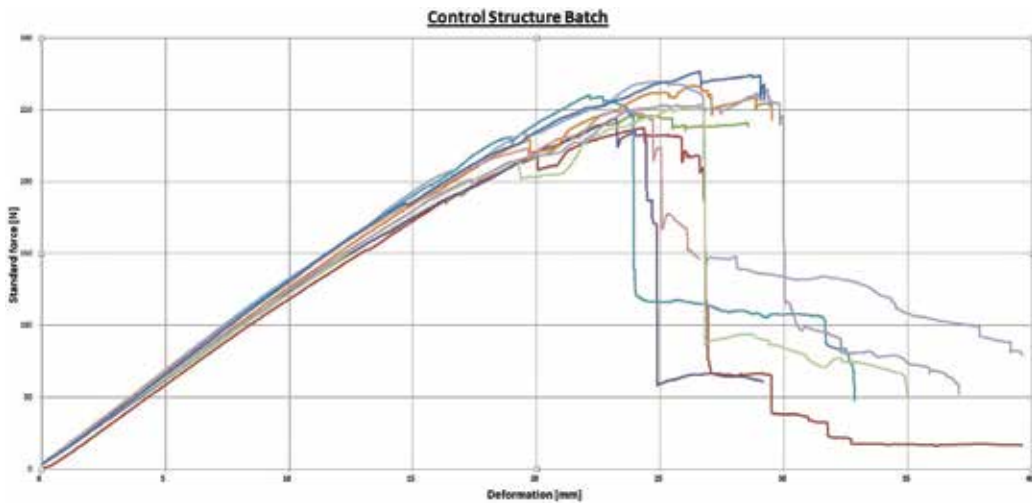
Figure 3. Collective data of three point flexural test.

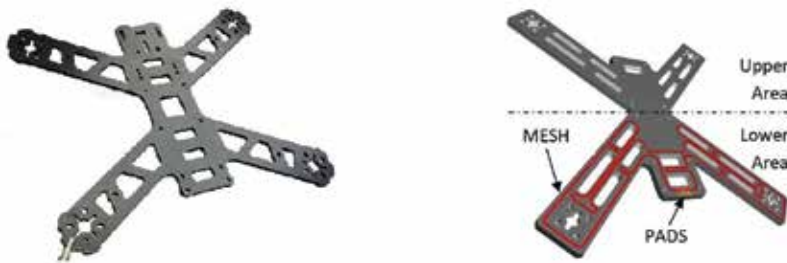
Figure 4. Traditional drone frame (left), enhanced NDT CAD frame (right).

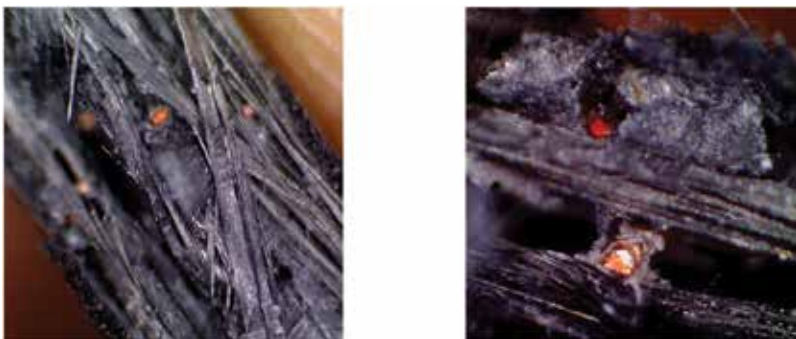
Figure 5. Tapering of conductive mesh (up to $\times 200$ magnification).

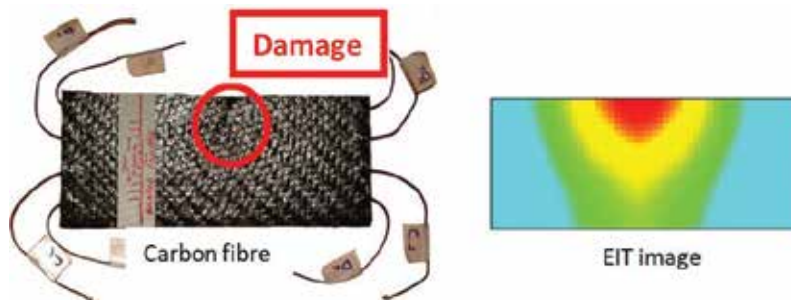
Figure 6. Test specimen & electrodes (left), expected EIT image (right).

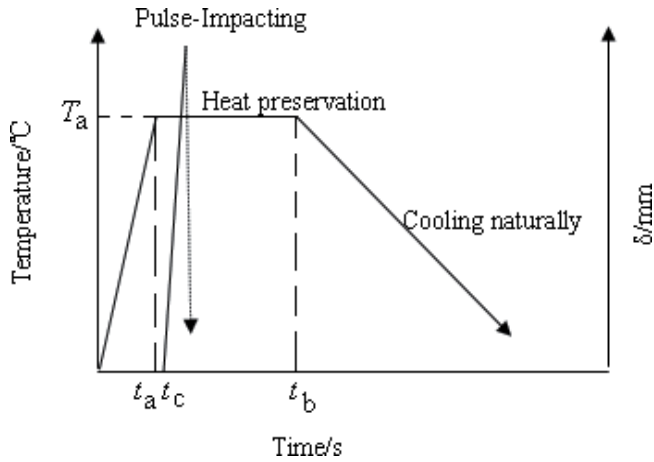
Figure 2. Schematic diagram of liquid-phase-pulse-impact diffusion welding.

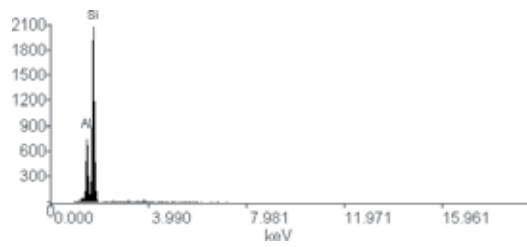
Figure 5. Energy-dispersive X-ray analysis of the fracture surface of SiC_p/A356.

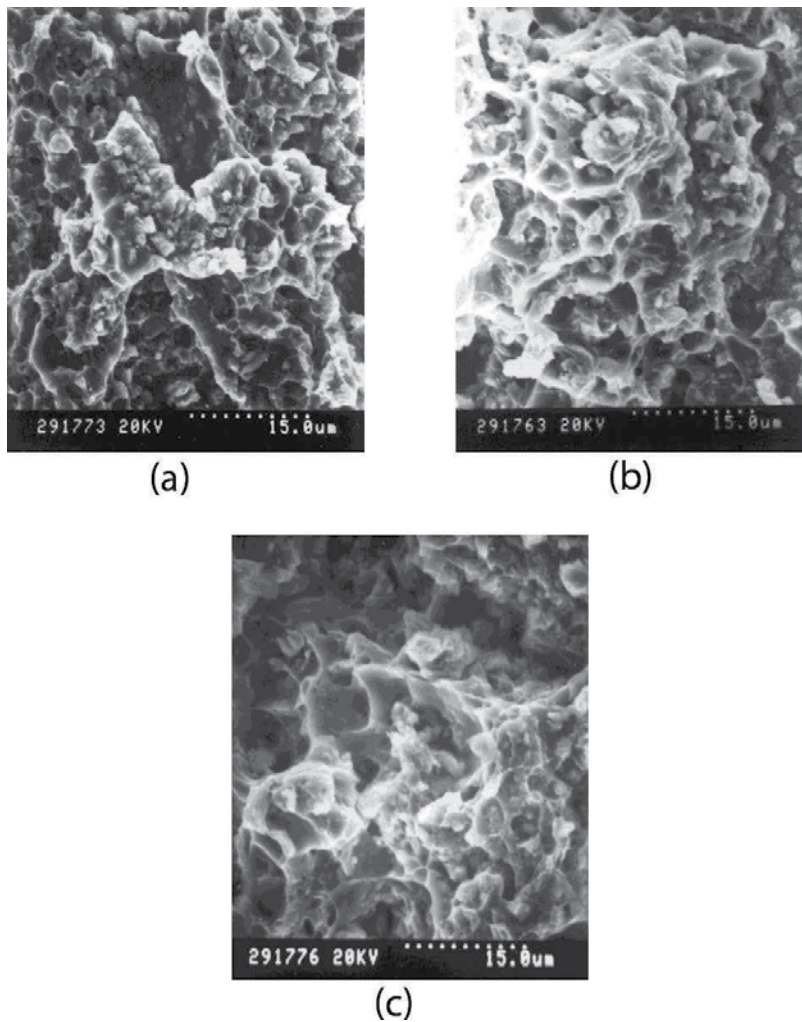
Figure 6. Fractographs of SiC_p/6061Al at various temperatures. (a) 620°C, (b) 623°C and (c) 625°C.

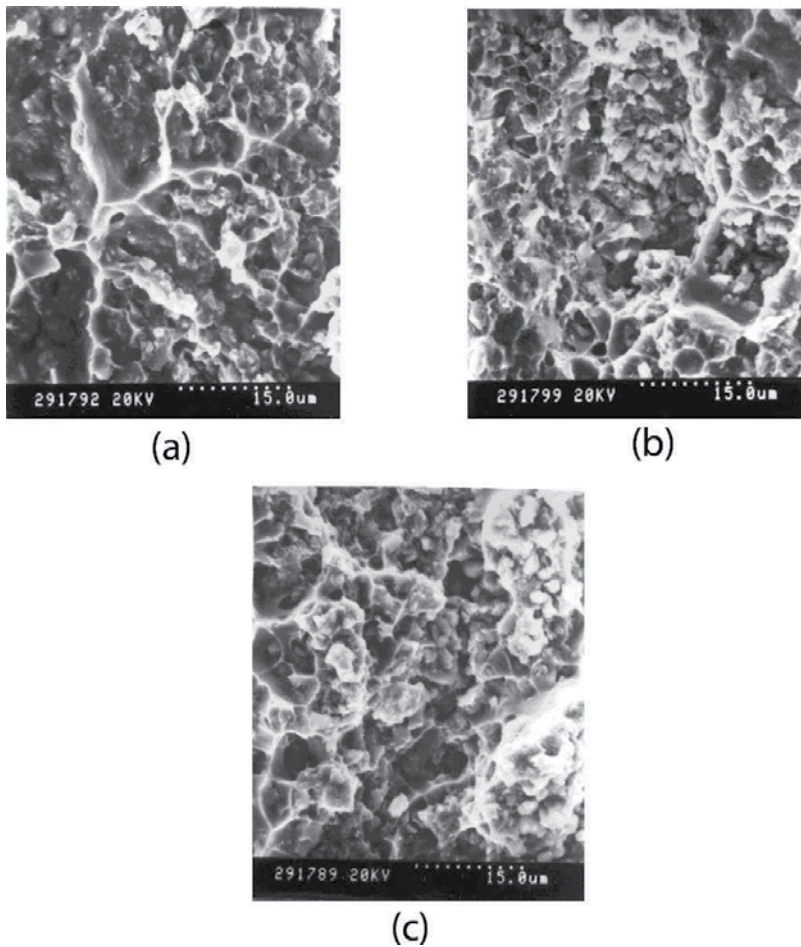
Figure 7. Fractographs of $\text{Al}_2\text{O}_3\text{p}/6061\text{Al}$ at various temperatures. (a) 641°C , (b) 644°C and (c) 647°C .

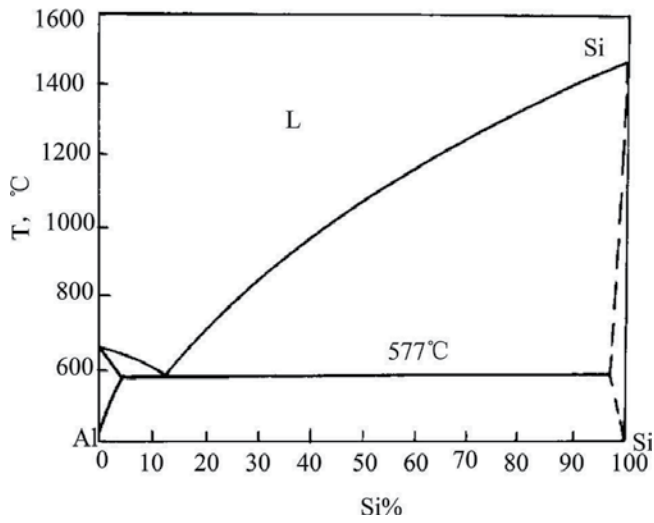
Figure 9. Binary alloy phase diagrams of al-Si [25].
