Engineering Failure Analysis

Edited by Kary Thanapalan

<http://dx.doi.org/10.5772/intechopen.84666>

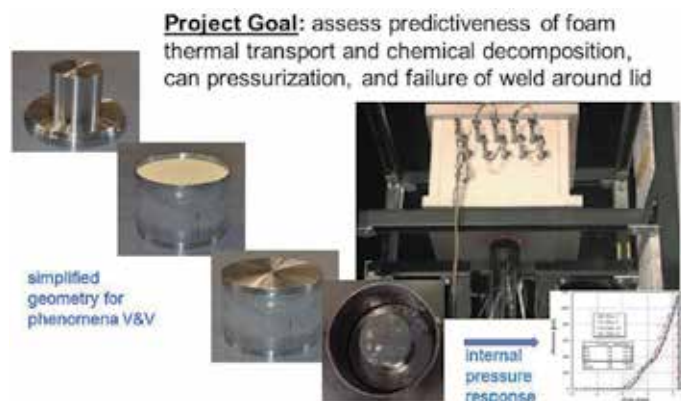
Figure 1. Thermal-chemical-mechanical validation experiments [2], including internal pressure response. The ‘can’ includes the cylindrical ‘sidewalls’ or ‘walls,’ as well as the top ‘lid’ and bottom ‘base.’

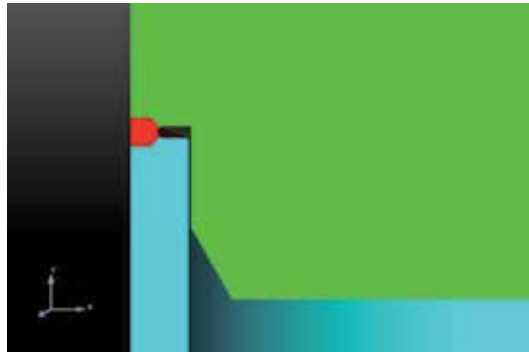
Figure 2. Close-up of modeled geometry where can top lid, sidewall, and internal foam meet. (Nominal geometry values are 0.03 in. weld depth, 0.0645 in. wall thickness, and 0.007 in. clearance between the lid and sidewall in the weld region.)

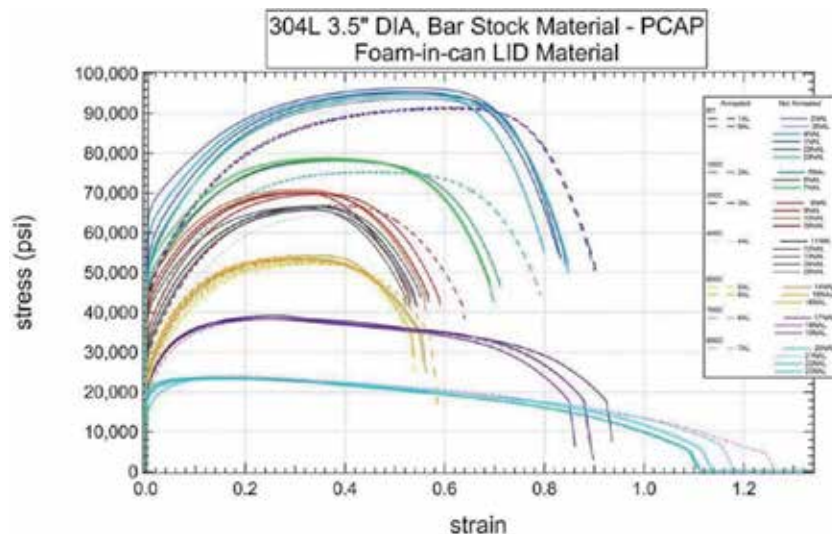
Figure 4.
Engineering stress vs. engineering strain curves for PCAP lid and base material (ss 304L, axial specimens from bar stock).

The test results for the PCAP lid material in the axial direction are shown in **Figure 4** in terms of engineering stress versus engineering strain. As expected, the strength of the material decreases as the temperature increases. However, around

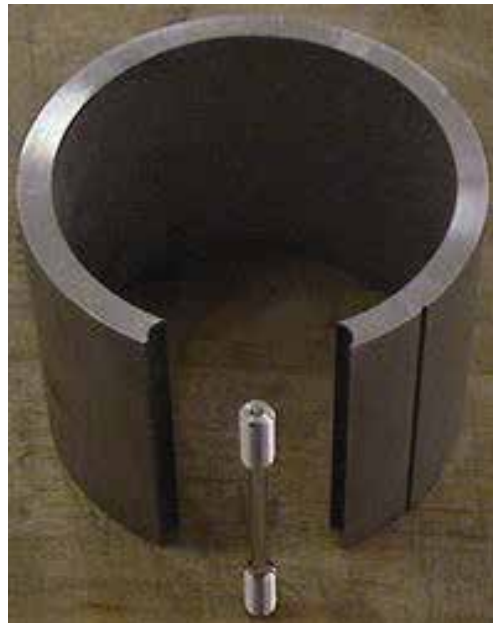
Figure 5.
Axial tensile specimen extraction from wall material.

Specimens in the axial direction were extracted from the tube-stock material as shown in **Figure 5**. The can sleeve/sidewalls were machined from this stock. The

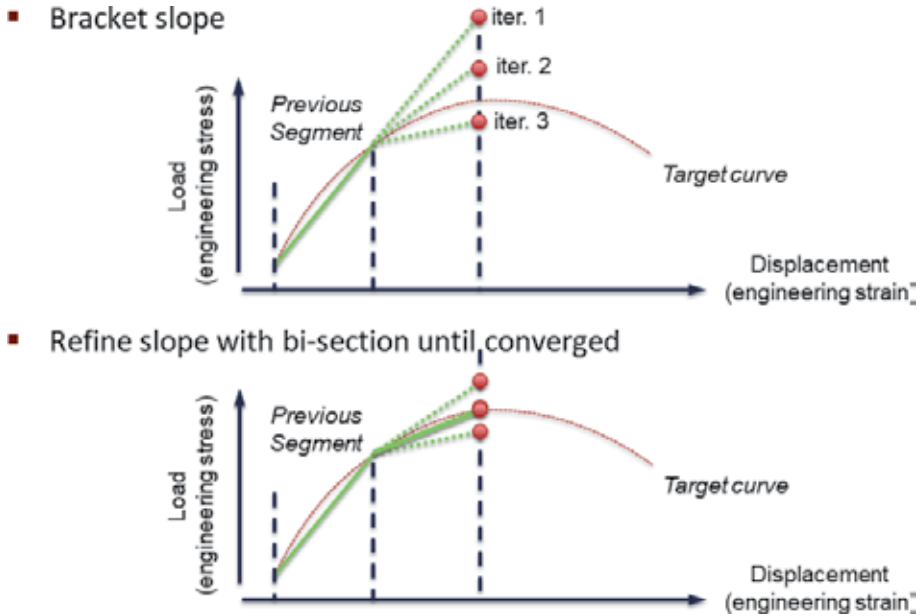
Figure 7. Iteration process to arrive at next point in piecewise linear parameterization of MLEP stress-strain curve.

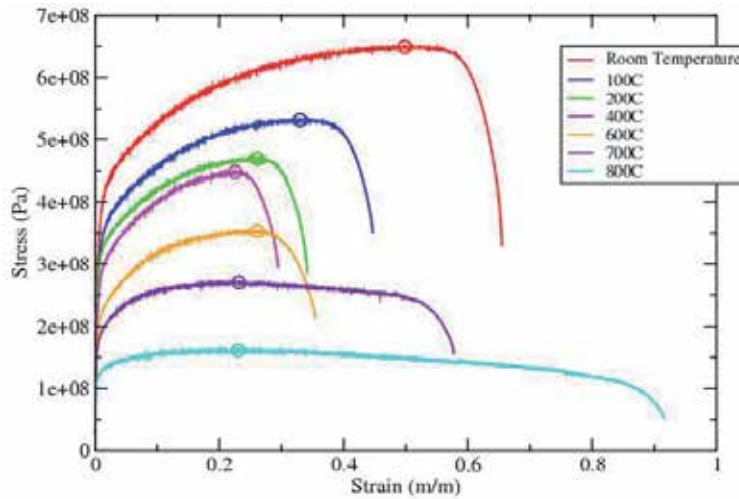
Figure 12. Maximum load locations (circled) where critical failure values of TP and EQPS are obtained (from ss 304L tube/wall material tension tests, only one curve is shown at each temperature for illustration).

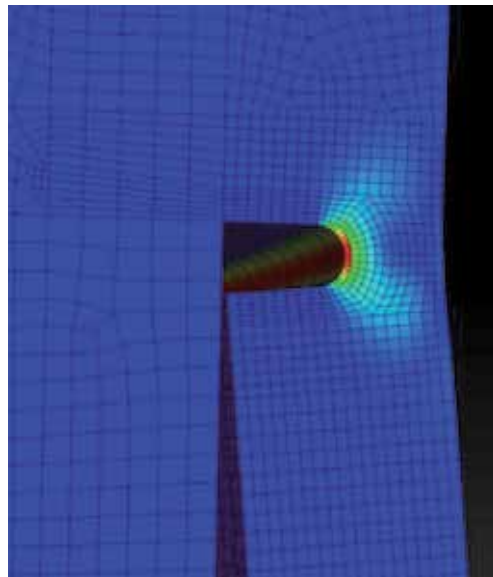
Figure 13. Weld-section close-up of structural-model Level 4 hex mesh used in model validation, UQ, and sensitivity analysis simulations in the PCAP project. Stress concentration is evident at the crown of the weld notch. (Figure from [3].)

Figure 13 shows the Level 4 mesh at a critical portion of the structural model where weld failure is determined in the thermal-structural simulations. Stress

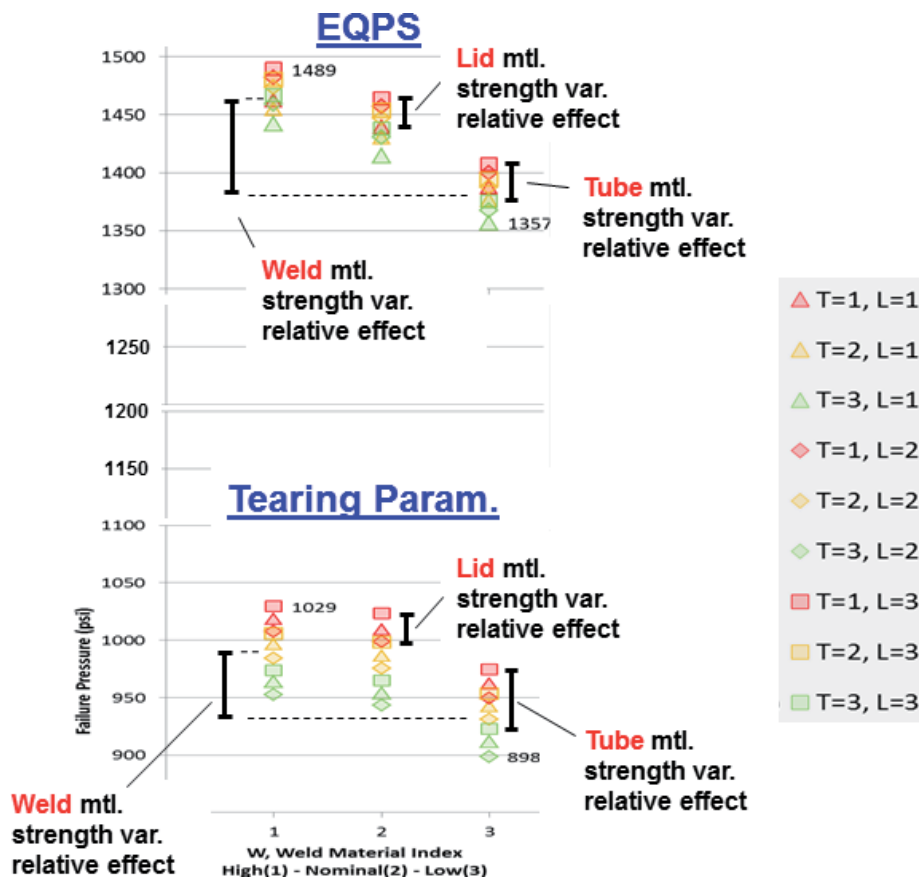
Figure 16. Predicted failure pressures and sensitivities for different combinations of lid, weld, and tube material strength functions.

The 27 failure pressures for the TP and EQPS failure criteria are plotted in **Figure 16**. The left columns of the TP and EQPS results are for the HS stress-strain function for the weld material coupled with nine different (all possible) combinations of lid and tube/wall strengths varied over their LS, MS, and HS options. Similarly, the center and right columns of results in the figure are, respectively, for

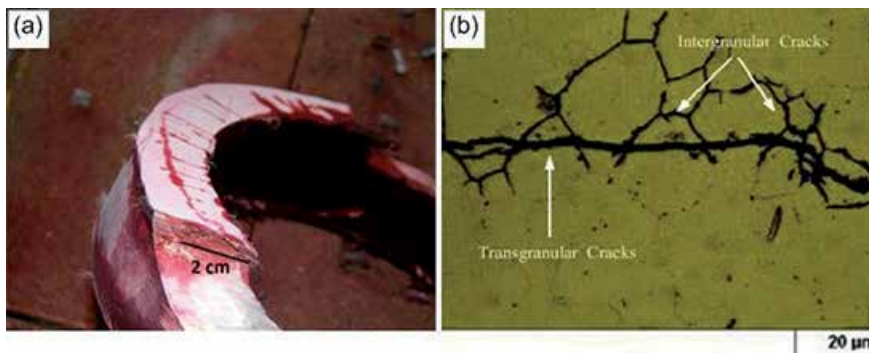
Figure 1. Macroscopic and microscopic feature of the stress corrosion cracking: (a) Cross-section of a failed tube and formation of macro branching cracks on it. (b) Optical micrograph of a typical SCC in AISI316L stainless steel exposed to chlorides [3, 4].

The branches developed, intergranular and transgranular cracks are the character of stress corrosion cracking in microscopic levels, **Figure 1b**. In intergranular mode, the cracks proceed along grain boundaries while transgranular cracks grow across the grains [3]. The mode of crack proceeds depends on the material micro-structure and environment.

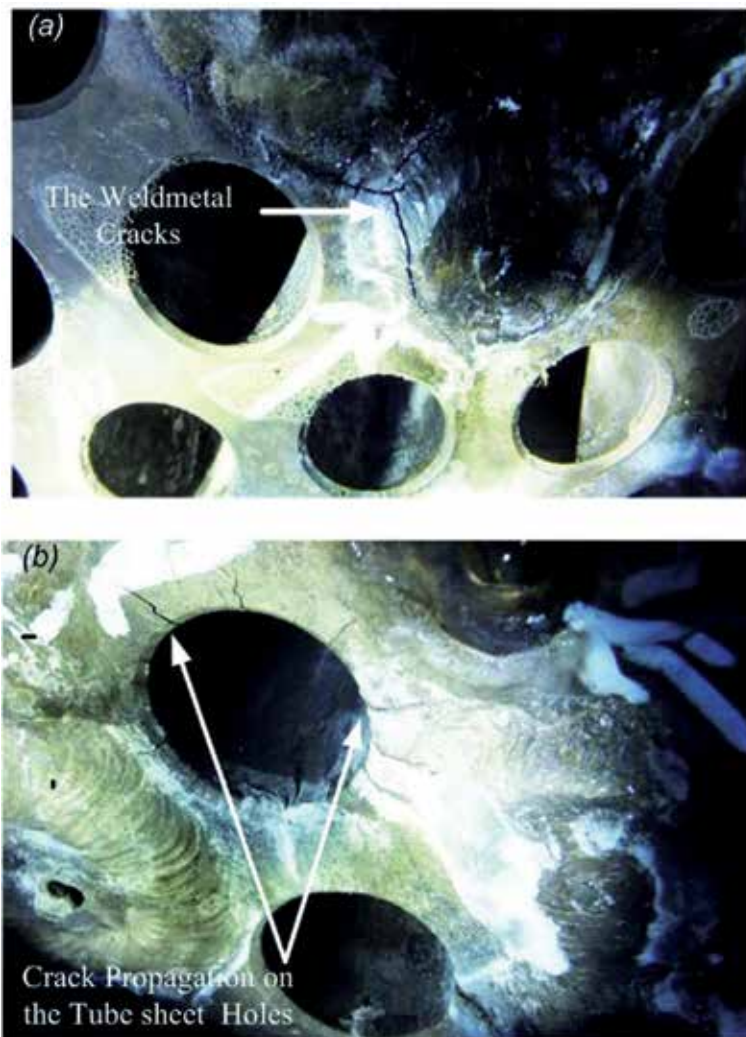
Figure 4. Two sources of stress in the SCC: (a) welding residual stress and (b) mechanical residual stress [3].

The main source of stress attributed to stress corrosion cracking comes from the residual stress. The well-known sources of the residual stress are welding and fabrication processes. Residual stress due to welding plays an imperative role in the stress corrosion cracking of metal alloys. In this area, two factors are determined. First, the welding residual stress by the cause of nonuniform temperature changes during welding, which can be computed by Eq. (1). Second, in some of the steel

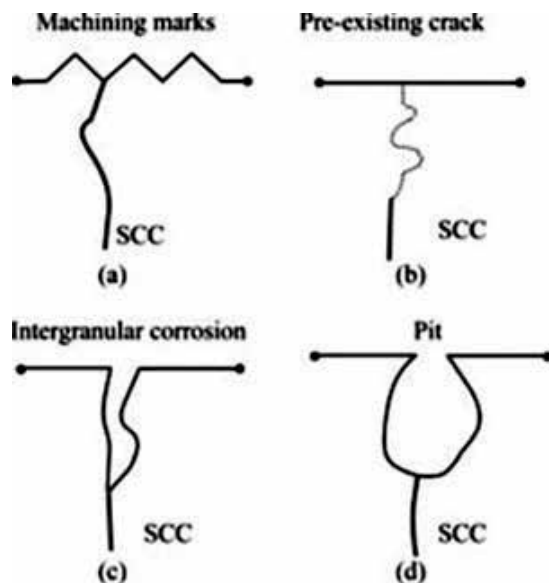
Figure 5. The sources of SCC sites (a) machining marks, (b) pre-existing crack, (c) intergranular corrosion, and (d) pit [28].

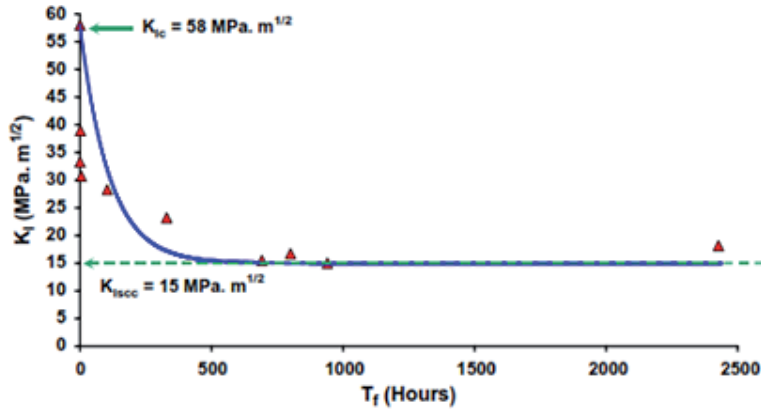
Figure 6. K_I vs. T_f of AISI4340 steel in 3.5% NaCl at ambient temperature [59].

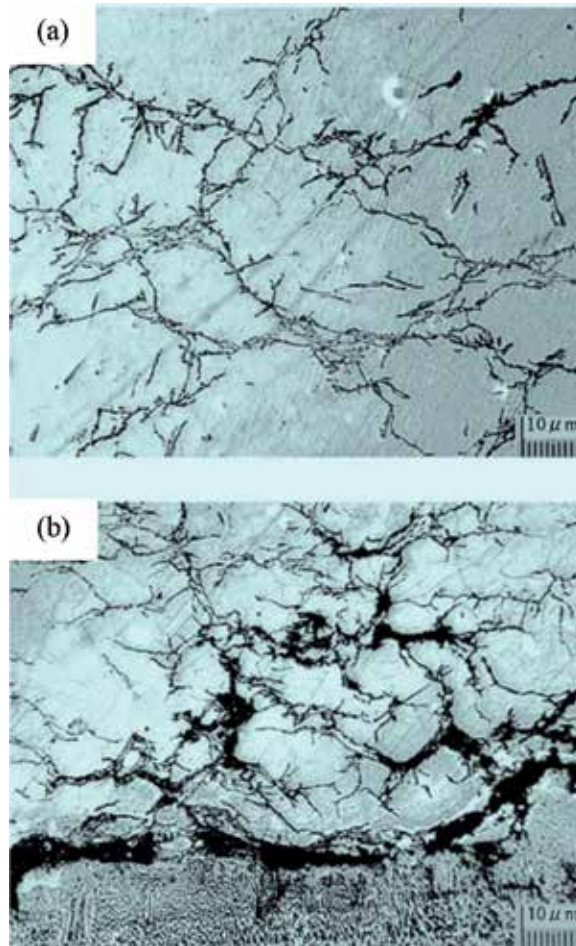
Figure 10.
The stress corrosion cracking: (a) heat affected zone and (b) the weld line.

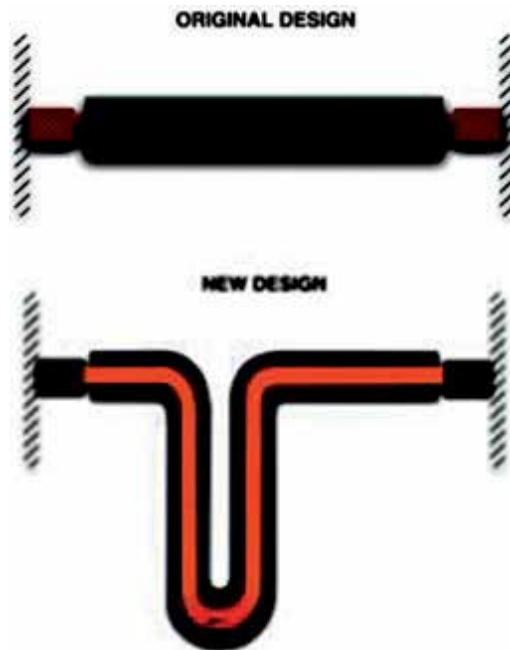
Figure 11.
New and old design of refrigerating system.

The phosphorized copper alloy tube failed due to SCC induced by a moist ammonia environment related the black foam insulation. Although the resistance of copper alloy under dry ammonia environment is notable, gathering of moisture ease by the bent tube geometry provokes the tubing to be exposed to wet ammonia, which is substantially more. The sensitivity of the copper tubing to SCC was

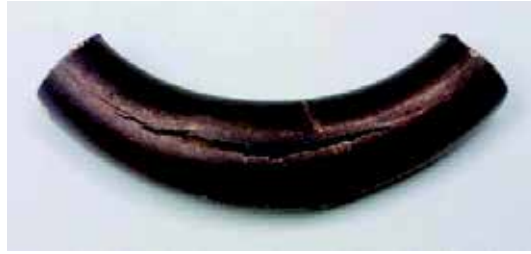
Figure 12.
Macroscopic image cracked copper tube.

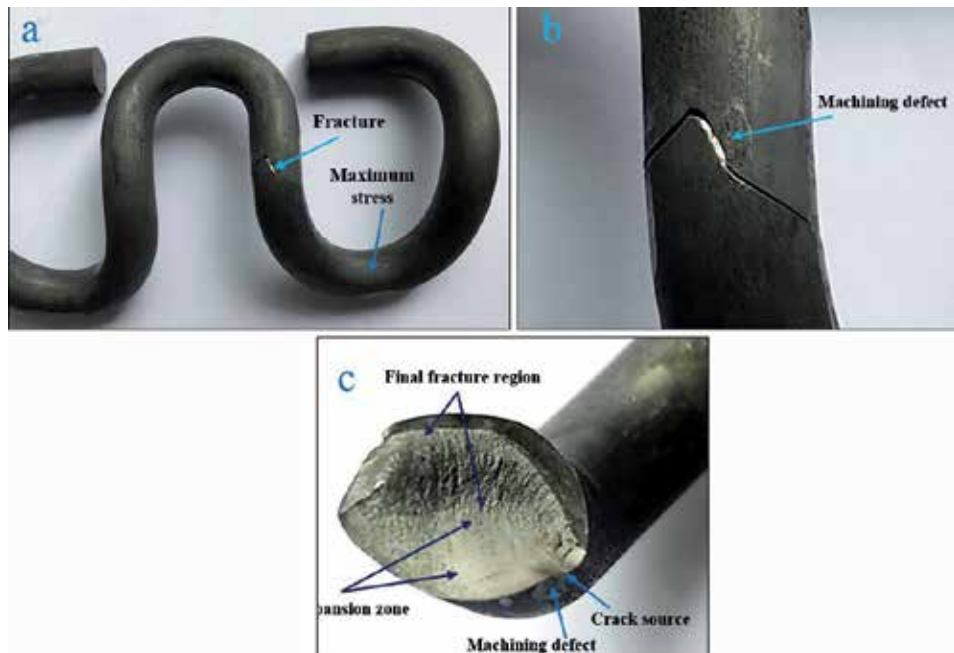
Figure 1. Macroscopic analysis of the premature fatigue fractured rail fastening clip caused by surface processing defects: (a) the overall morphology of the fractured clip, (b) the processing defects near the crack initiation region, and (c) the morphology of the fractured surface.

Figure 1 shows the fracture condition of a rail fastening clip after the fatigue test of 4×10^5 cycles. However, according to the TB/T2329-2002 Chinese standard for the fatigue tests of rail fasteners, the samples should not fracture after 5×10^6 cycles. In order to find out the reasons of the premature failure, macroscopic analysis was conducted on the failed sample. As shown in **Figure 1a**, the fracture surface is not located in the position bearing the maximum stress during fatigue tests. The detailed observation reveals that a processing defect exists near the crack initiation region, as is shown in **Figure 1b**. This defect is mainly caused by the excessive extrusion of the hot plastic mold during induction heating, resulting in a local stress concentration at the defect. Subsequent quenching further increased the local stress at defects. During the fatigue tests, crack initiated from the stress concentrated position at the defects leading to the premature failure of the tested sample. As shown in **Figure 1c**, the characteristics of the fracture surface were revealed by the macroscopic analysis. The fracture surface shows the feature of a typical fatigue failure mode. The crack initiation region, crack expansion zone, and the final fracture region can be clearly observed on the fracture surface as marked in **Figure 1c**. Since the crack expansion zone occupies a large area, it indicates that,

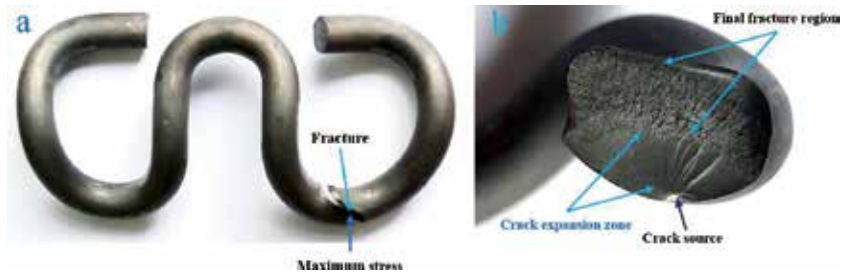
Figure 2. The macroscopic morphology of the premature fatigue fracture samples processed by the high-frequency-inducing heating.

Another example shows the effect of the producing process on the failure conditions of the rail fasteners. In order to improve production efficiency and reduce cost, the rail fasteners are subjected to medium frequency induction heating treatment before being deformed into the “M” shape. Then, the railway fasteners were quenched by the residual heat of induction heating after the thermoforming. In order to further reduce costs and improve efficiency, a company replaced the original intermediate frequency induction heating with high frequency induction heating in the production of railway fasteners. Because the heat generated by the high-frequency induction

heating is more concentrated on the sample surface, it is easy to cause the uneven heating of the samples, resulting in large residual stress. In addition, the macroscopic factors such as insufficient heating time, insufficient heating power, or incorrect heating location of the sample may cause the inhomogeneity of the microstructure in the heat-treated samples. This type of microstructural inhomogeneity will lead to the property difference in certain regions, which can greatly reduce the fatigue life of the railway fasteners and cause the premature fatigue failure. **Figure 2** shows the fracture condition of railway fasteners, and the fatigue test is carried out after the high-frequency-inducing heating process. The premature failure occurred after 1.2×10^6 fatigue cycles (normally 5×10^6 cycles without fracture).

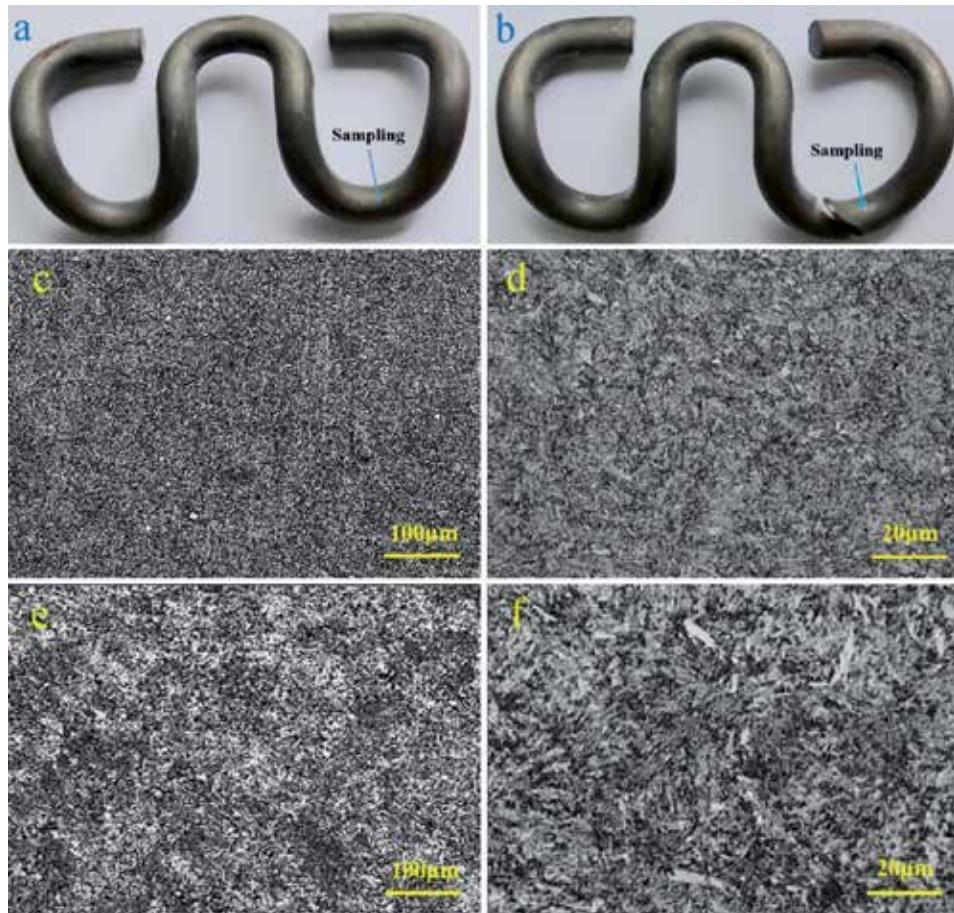
Figure 3. The sample extraction position of normal (a) and prematurely failed railway (b) fasteners. (b, c) and (e, f) are the corresponding metallographic microstructure of the normal and prematurely failed fasteners, respectively.

As shown in **Figure 3a** and **b**, the samples for microstructure observation of the normal and prematurely failed fasteners were cut from the same position near the fracture surface. The samples were ground by SiC paper and polished. The Nital solution (4% alcohol solution of nitric acid) was used as the etching solution. An optical microscope was used to complete the microstructure observation of the samples, and the results are shown in **Figure 3c–f**. **Figure 3c** and **d** shows the microstructure of the normal railway fastener after quenching and tempering in the medium temperature range; the typical tempered troostite and a small amount of ferrite can be clearly observed. The troostite and ferrite grains are fine, and they distributed evenly in the microstructure. **Figure 3e** and **f** shows the microstructure of the prematurely fractured samples. The obvious microstructure segregation

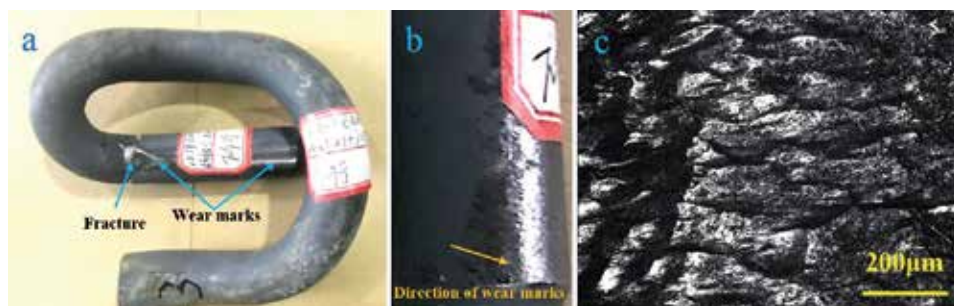
Figure 4. The macroscopic morphology and surface wear scars of the fractured metro fastener: (a) the macroscopic morphology of the failed fastener showing the position of the fracture surface and the wear marks, (b) the obvious wear scar that can be observed on the surface of the straight section of the fastener clip, and (c) the enlarged view of wear scar.

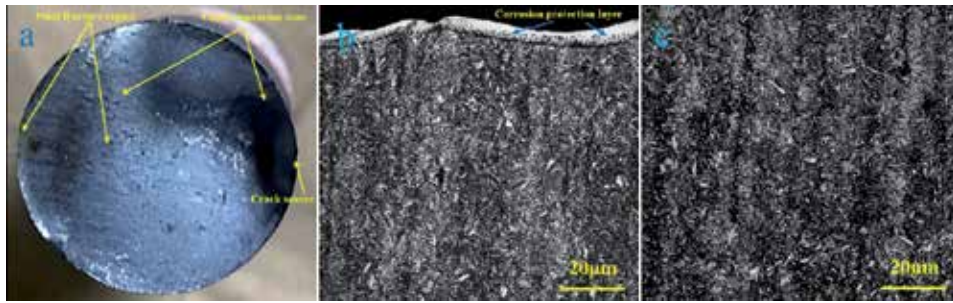
Figure 5. The macroscopic morphology of the fracture surface and the microstructure of the samples near the fracture surface: (a) the fracture surface morphology, (b) the cross-sectional microstructure of the sample near the fracture surface, and (c) the microstructure of core region of the sample near the fracture surface.

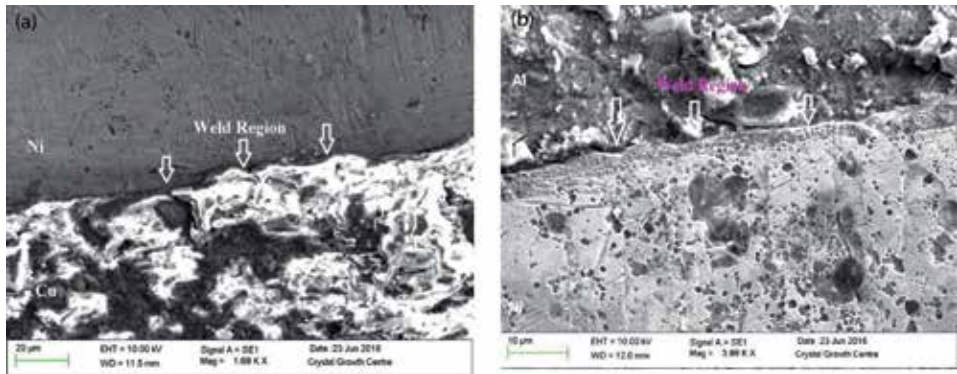
Figure 12. Interface of specimen welded observed under FESEM at 1000 rpm: (a) copper side and (b) aluminum side.

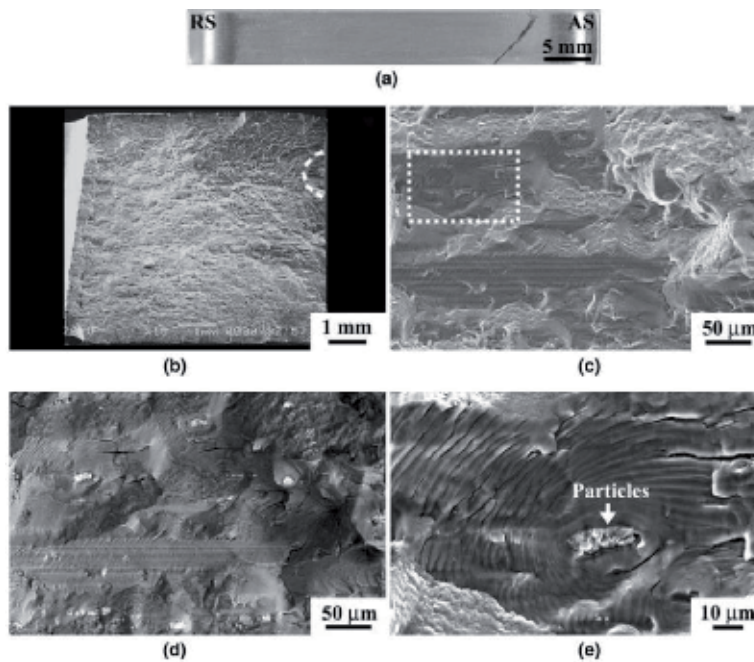
Figure 15. Different failure locations in friction stir welds [6].

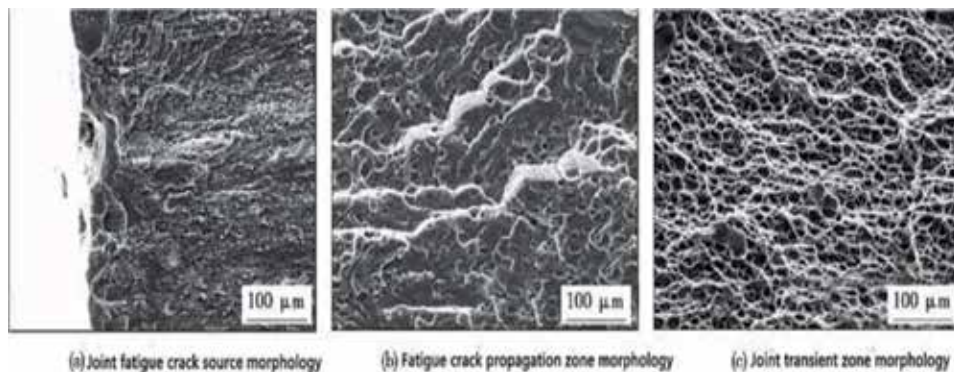
Figure 16. Fatigue crack propagation in 6005 friction welded joints [7].

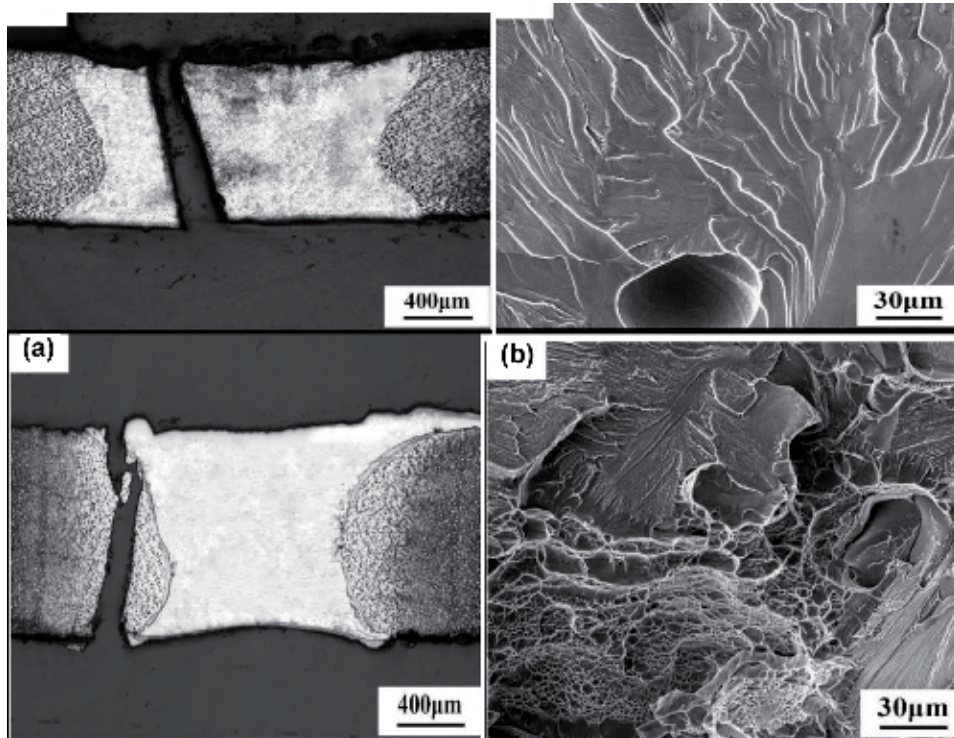
Figure 23.
(a) The fracture path and (b) fracture surface morphology of the joint without filler metal.

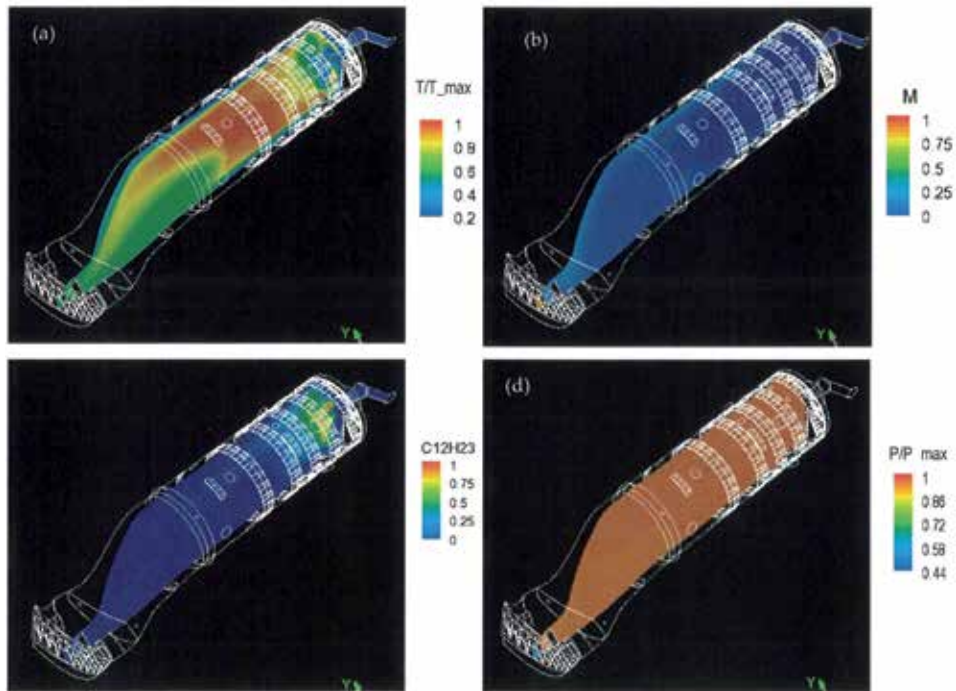
Figure 3. Flow parameter distributions at the mid-longitudinal section: (a) normalized static temperature, (b) Mach number, (c) $C_{12}H_{23}$ mass fraction, and (d) normalized static pressure.

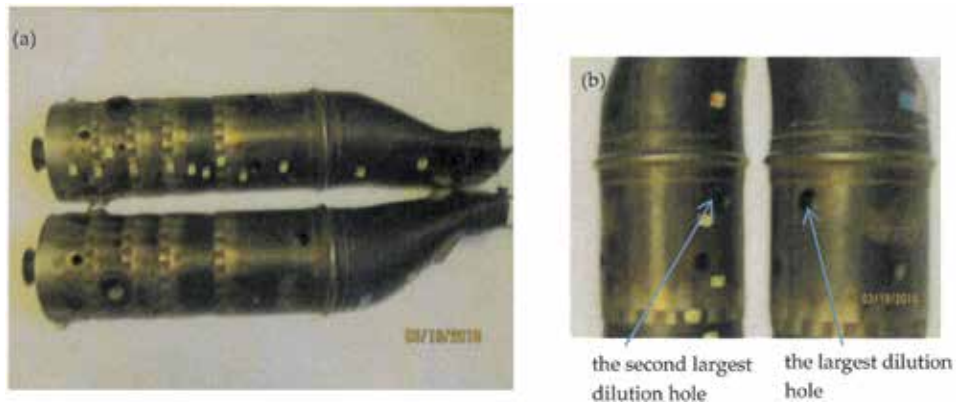
Figure 6. Combustion can: (a) two halves and (b) the two dilution holes before the contraction section.

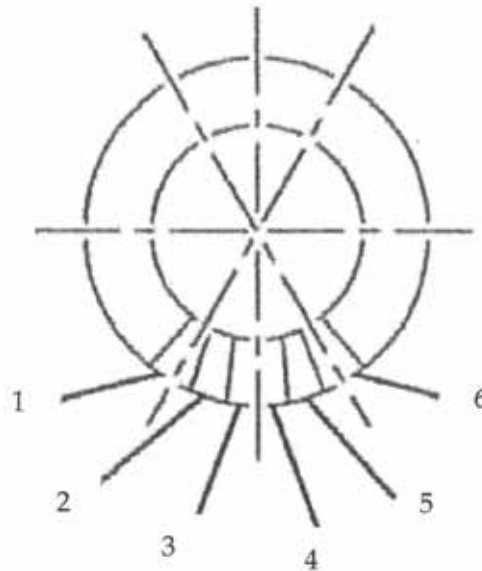
Figure 8.
 The locations of six NGV units relative to the combustion can exit, looking upstream.

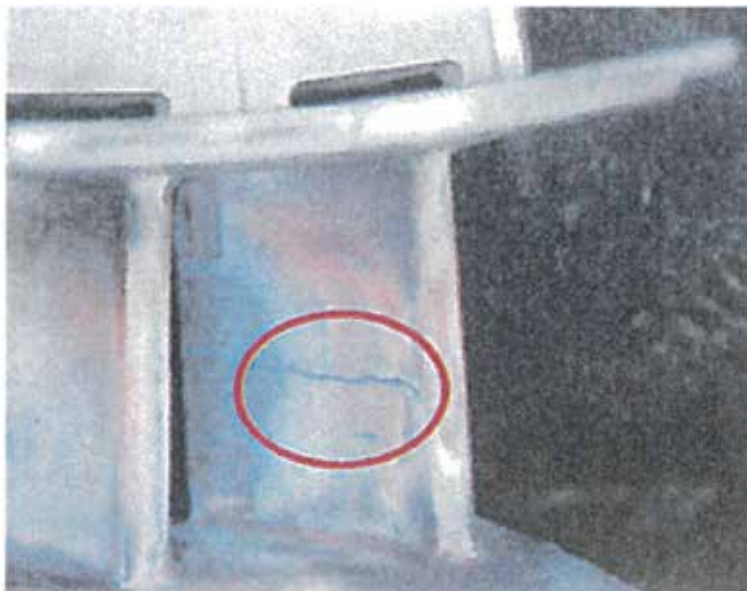
Figure 12. Typical mid-span cracking on the pressure sides.

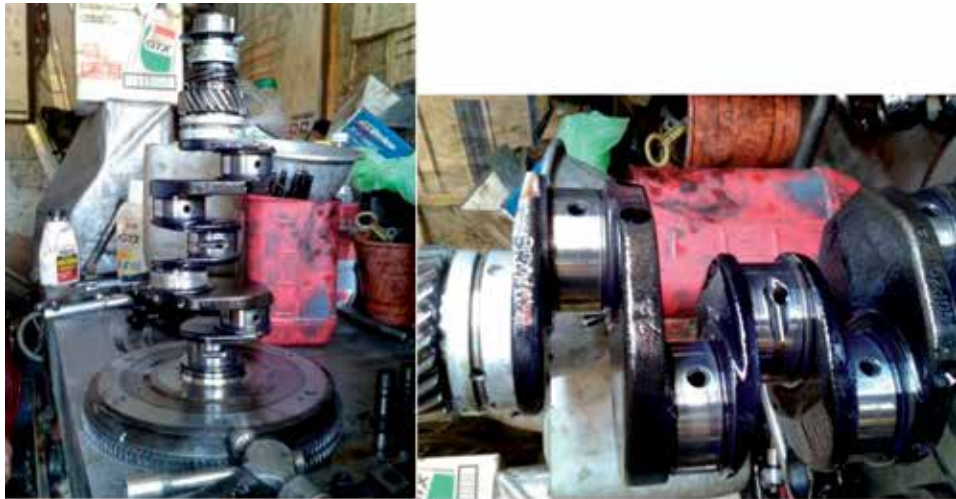
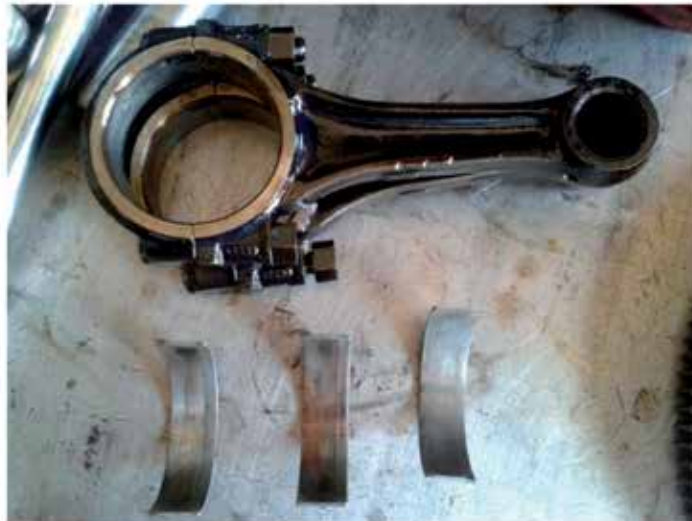
Figure 2.
Adjust of car engine: (a) and (b) crankshaft and (c) connecting rods and bearings.

The tribological characterization of the connecting rod bearings was carried out once the worn bearings were extracted from the internal combustion engine. It was possible because the car engine was adjusted. It is important to mention that these bearings had a service life of approximately 8 years. In **Figure 2a–c**, it is possible to observe the complete crankshaft, the connecting rods, and a few worn bearings after disarming.

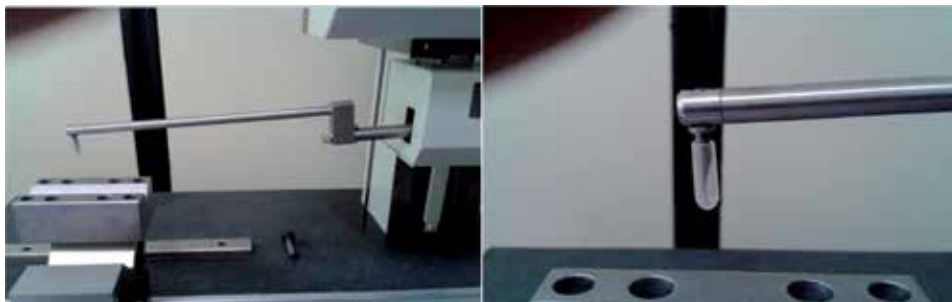
Figure 9.
Contour measuring instrument CV-500.

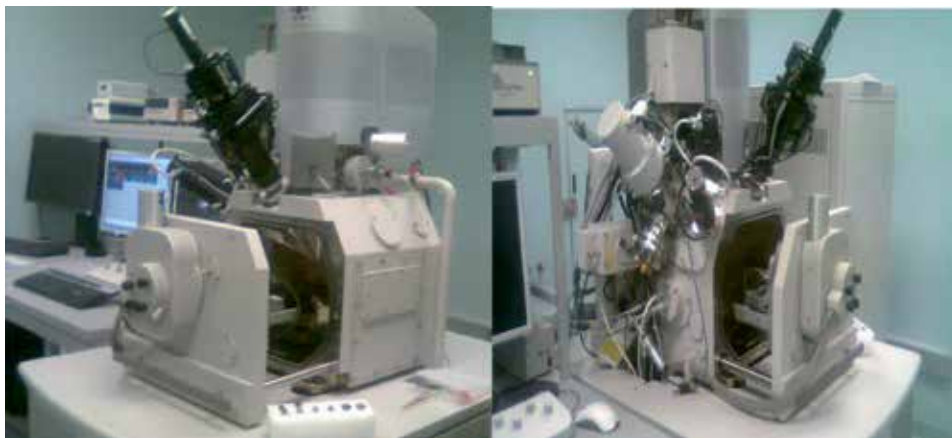
Figure 11.
Scanning electron microscope.

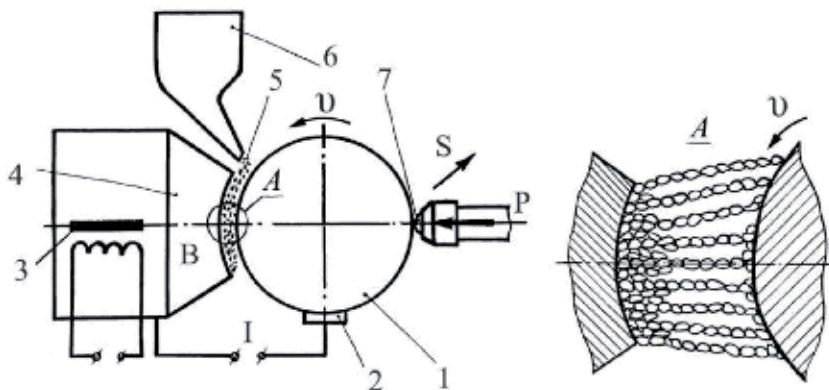
Figure 12. Electromagnetic surfacing with surface plastic deformation: 1—workpiece; 2—sliding contact; 3—electromagnet; 4—pole piece; 5—ferromagnetic powder; 6—dosing device; 7—ball runner; v —main speed; S —feed rate; P —deformation force; B —magnetic induction; I —electric arc current strength.

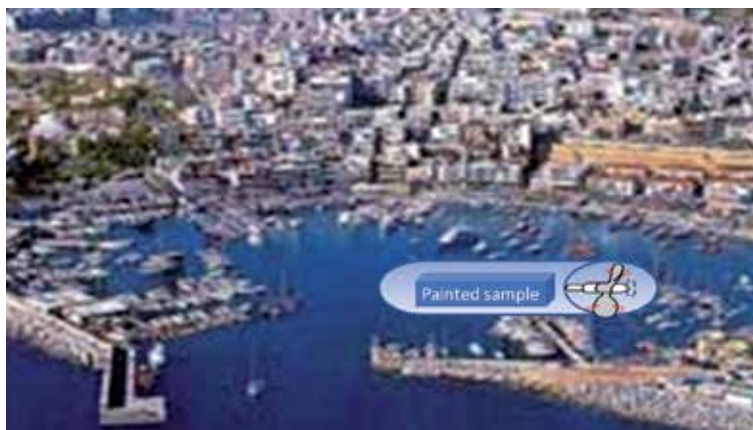
Figure 2.

Tube with samples placed in Mikrolimano (Piraeus) for 3 months. The motion of a ship with 14 knots simulated using at the end of the tube a propeller.

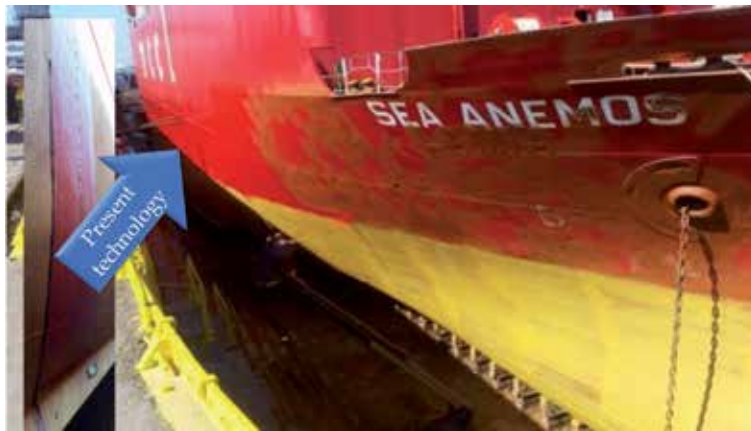
Figure 6.
Ship painted with nanotechnology.

stripe that was painted, and the rest of the ship was painted with the commercial coatings (primer, anticorrosion, and antifouling paints). After a year, the ship was taken out in a shipyard near Piraeus (Skaramagas shipyard, in a port town in the western part of Athens), and the result is shown in **Figure 6**. To our surprise, the

stripe we painted with the “nanotechnology paints” was nearly without fouling as compared with the rest of the ship painted with the “commercial paint.”

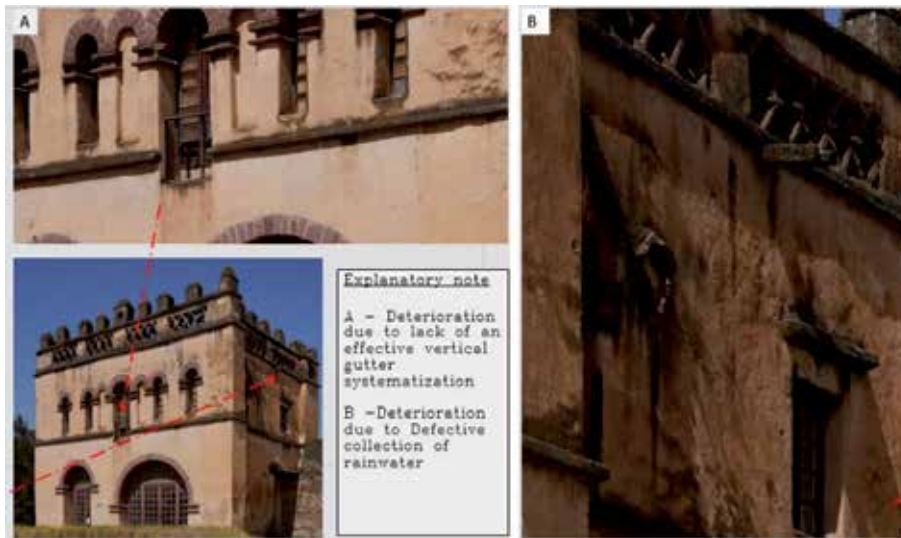
Figure 2.
The effect of improper rainwater removal on the face of the wall [29].

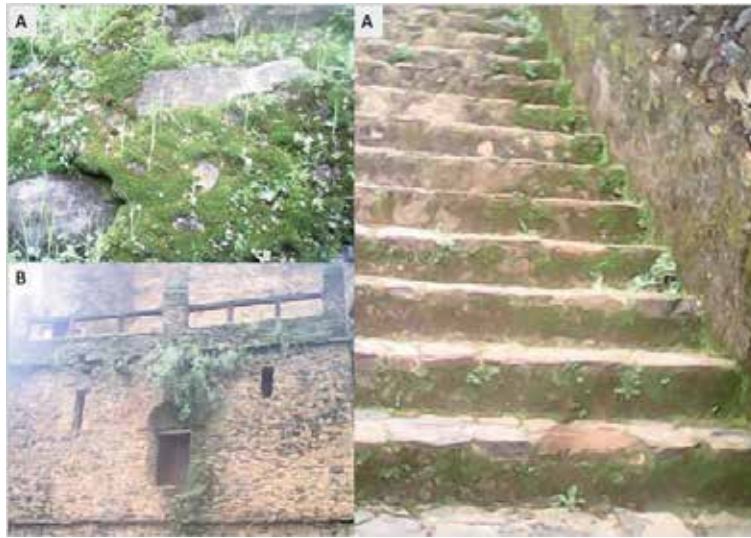
Figure 3.

The progressive biodeterioration processes on the surface of building materials: algae constitute the medium for the growth of fungi that pass through the building material by means of their hyphae. Dense formations of herbaceous plants [A] vascular plants [B] mosses and algae [source; Eskinder Desta].

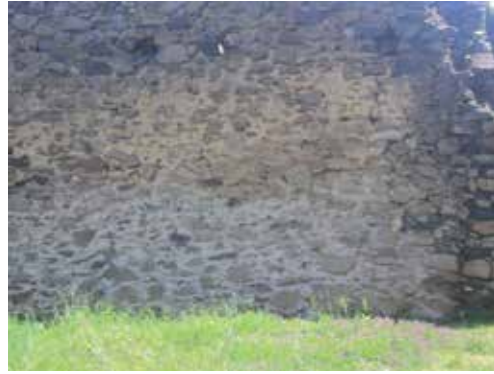
Figure 4.
 A widespread lack of binding mortar in between the stone masonry [source; Eskinder Desta].

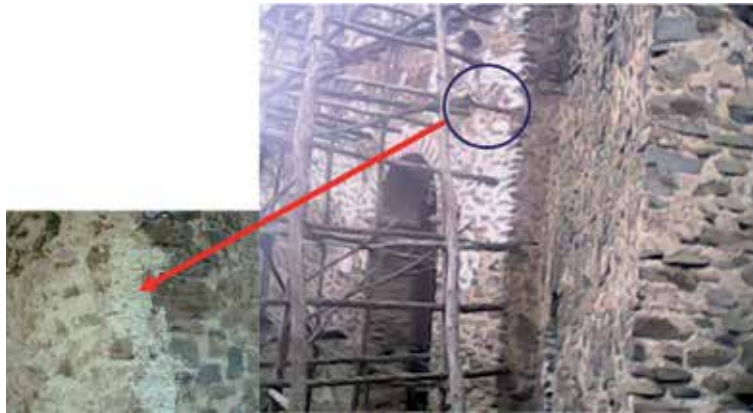
Figure 5.
 Mortar repointing used during the restoration of the palace [source; Eskinder Desta].

The major raw materials used for restoration works (lime) were transported from the south west part of Ethiopia, which makes it very challenging to perform a frequent restoration work. Some of the maintenance related issues of the Fasil Ghebbi palace are listed underneath [4, 22] (**Figure 5**) (**Table 2**).

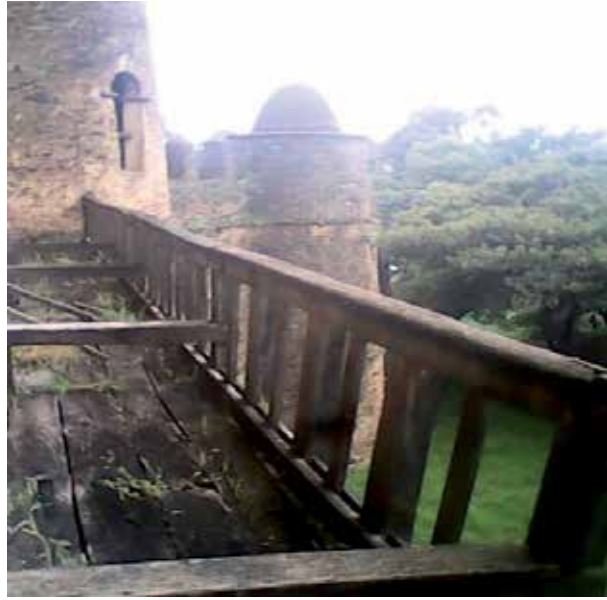
Figure 6. Active durability issue due to the presence of grass and alga on the wood floor terrace [source; Eskinder Desta].

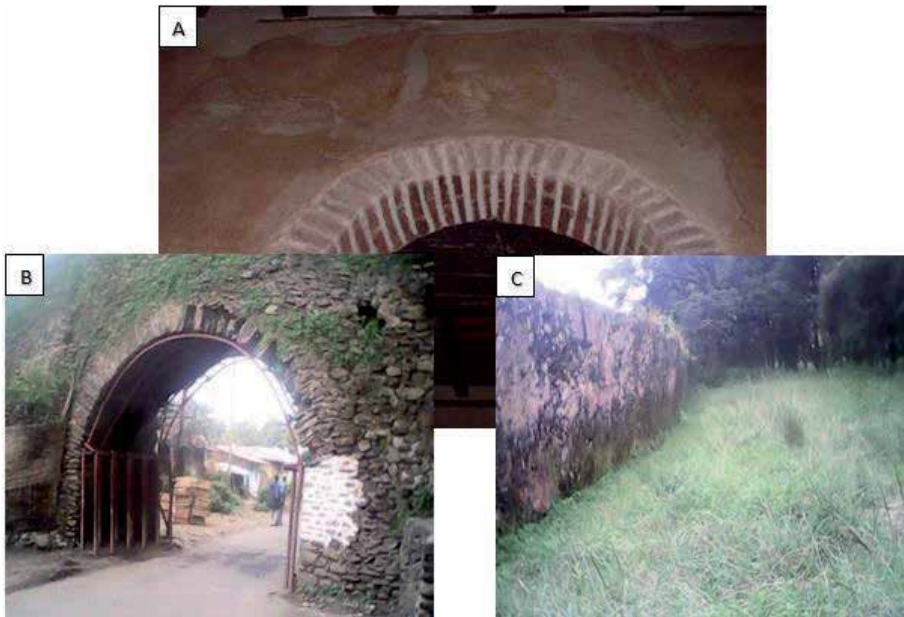
Figure 7. Active durability issues risking the palace: (a) crack formation inside the palace internal partition wall (repointed surface), (b) steel frame support aimed for the enhancement of stone masonry dome structure, and (c) tilting of the stone masonry wall inside the main palace yard [source; Eskinder Desta].

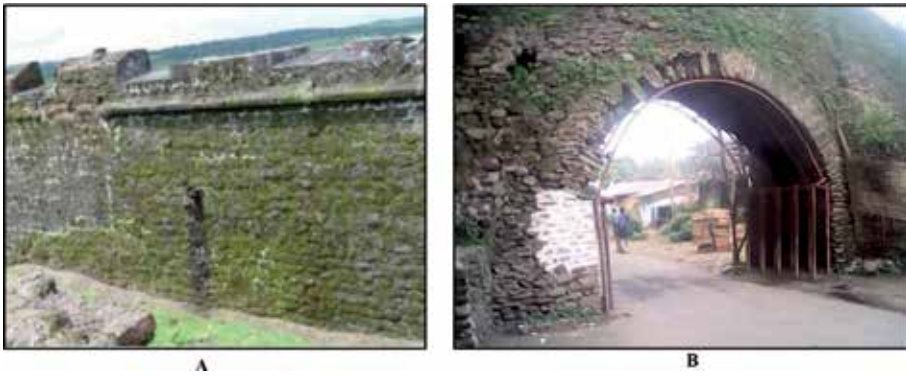
Figure 11. Biological growth at Fort San Lorenzo (Panama); source and Fasil Ghebbi [source; Eskinder Desta].
A. Biological growth at Fort San Lorenzo (Panama). B. Biological growth at Fasil Ghebbi.

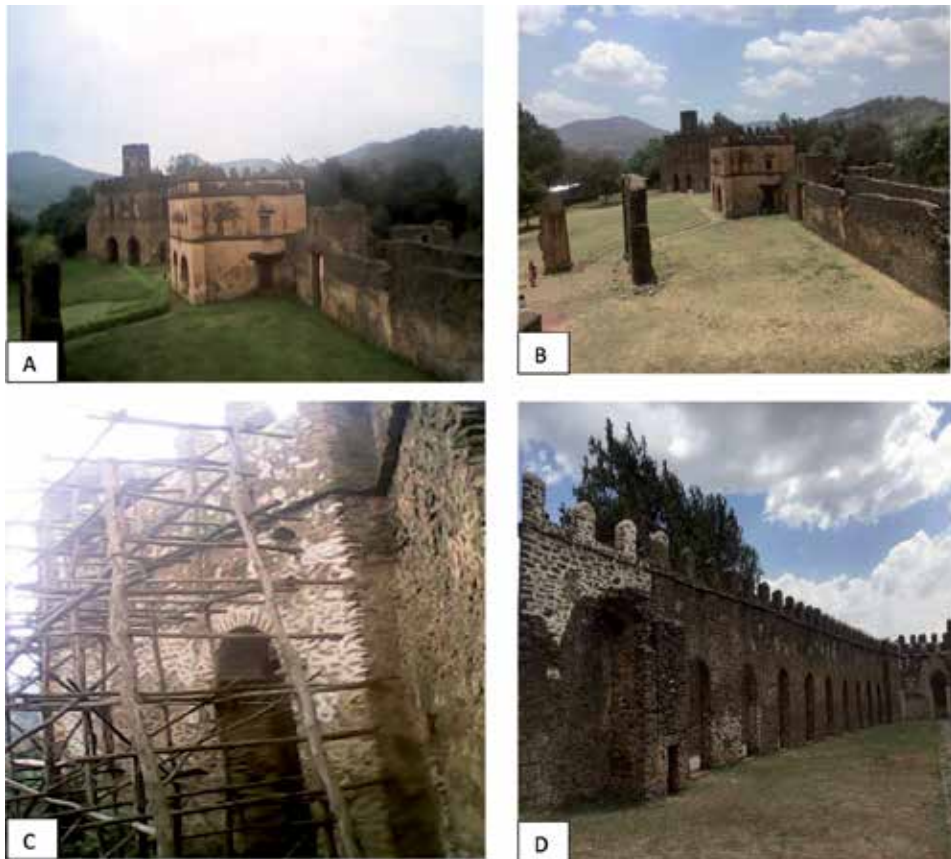
Figure 12. Some selected spots inside the royal palace before and after restoration. (A and C): in 2015; (B and D): in 2019 [source; Eskinder Desta].
